DASH POINT PARK

Pier Condition Assessment

Tacoma, Washington

September 2021

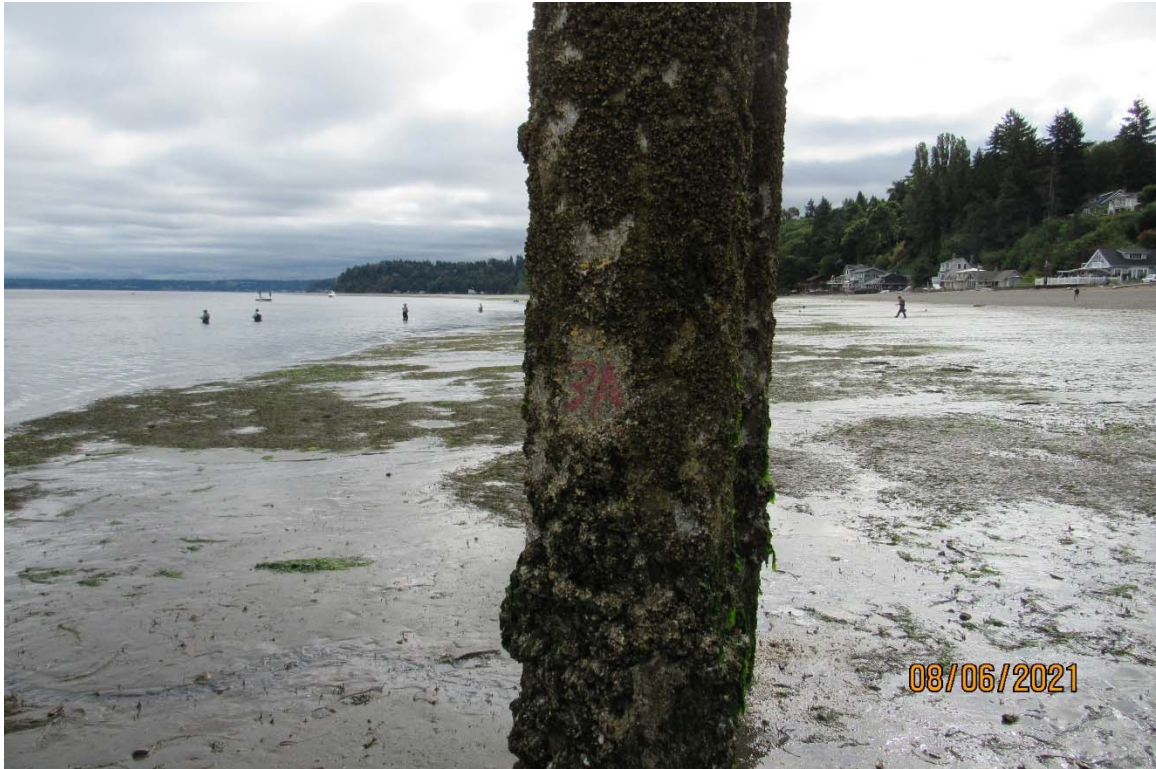
Above water, a layer of marine growth consisting of soft algae, mollusks, and barnacles up to 2 inches thick was observed on all pile surfaces, extending from the waterline to approximately 2 feet from the top of the pile. Select areas of the piles were cleaned, which revealed that the surfaces were typically hard, smooth, and sound with no notable defects. No heavy areas of section loss were observed.

Figure 3.2.1-1. View of typical structural pile condition, Pile 3:A shown, looking East.

Repair Recommendations: The precast pre-stressed concrete piles are considered fit-for-purpose. No defects were found of sufficient size or severity to warrant remedial action at this time. For routine maintenance, it is recommended that any cracking, delamination, or section loss be patched by removing any loose and unsound concrete, cleaning any exposed reinforcing steel, and a marine-approved concrete mortar be reapplied.

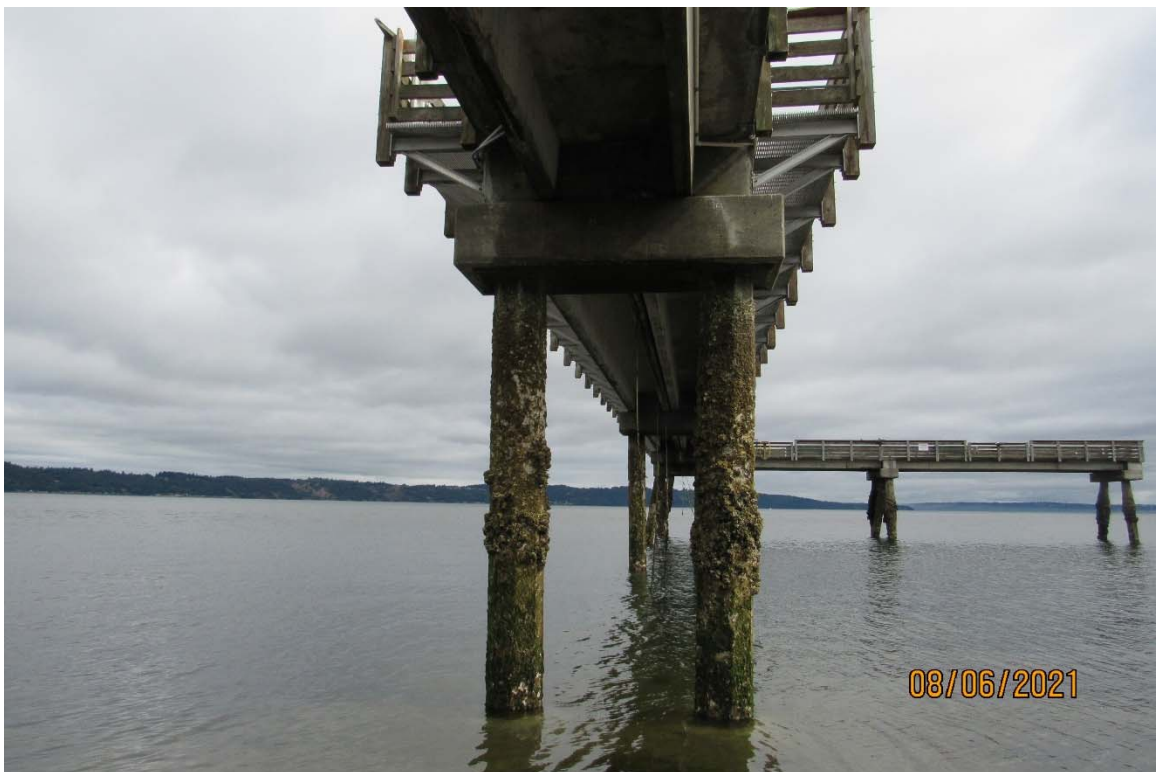
Figure 3.2.1-2. View of typical structural pile configuration, Bent 4 shown, looking North.

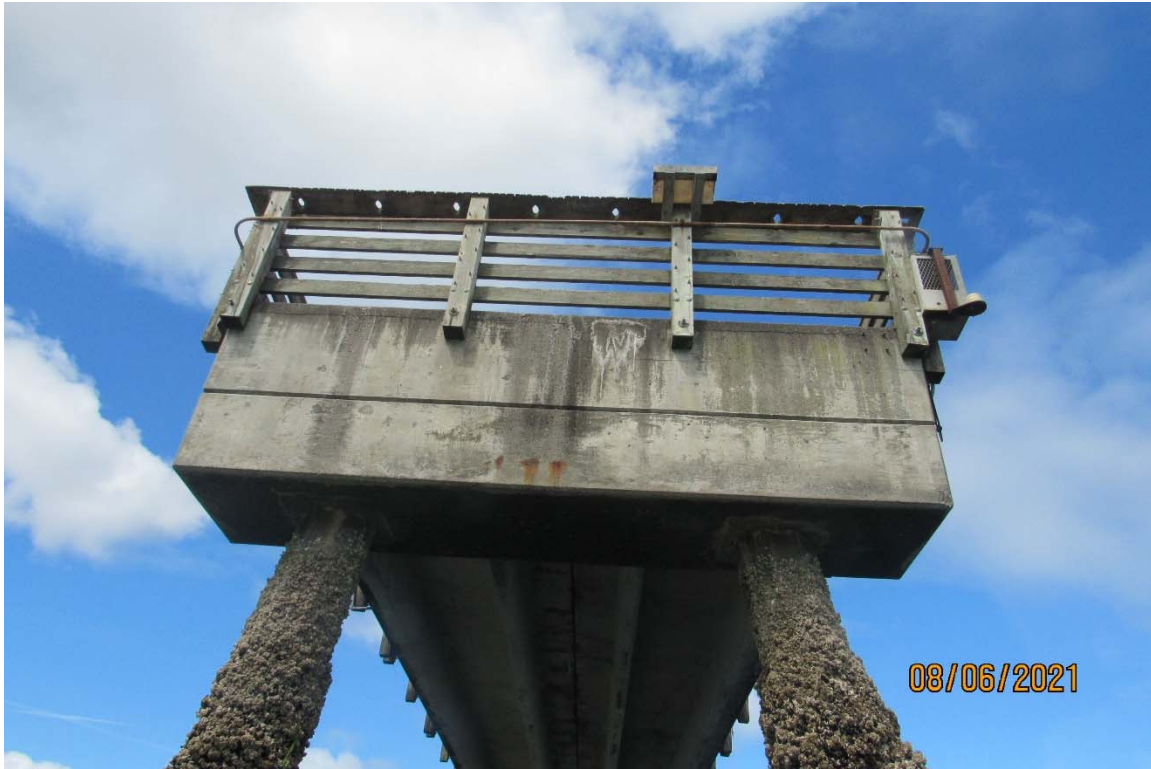
Figure 3.2.2-1. View of the typical pile cap condition, Bent 10 pile cap shown, looking west.

Repair Recommendations: The concrete pile caps are considered fit-for-purpose. No defects were found of sufficient size or severity to warrant remedial action at this time. For routine maintenance, it is recommended that any cracking, delamination, or section loss be patched by removing any loose and unsound concrete, cleaning any exposed reinforcing steel, and a marine-approved concrete mortar be reapplied.

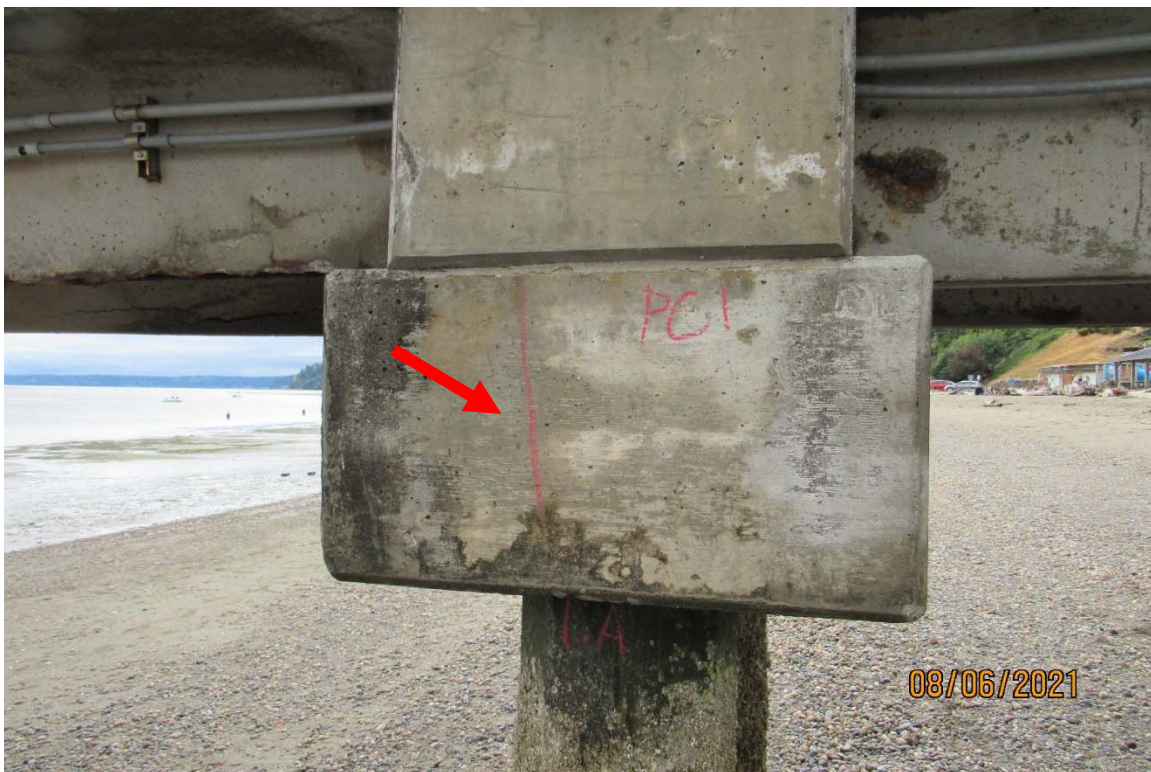
Vertical and horizontal cracking measuring up to 1/32 inches wide was observed on the pile caps at Bents 1 (two areas), 6, 7, 8, and 10. Rust staining was observed on the pile caps at Bents 2, 3, and 6, typically on the underside of the pile cap at the interface with the structural pile.

Figure 3.2.2-2. View of vertical cracking in the west face of the Bent 1 pile cap, looking east.

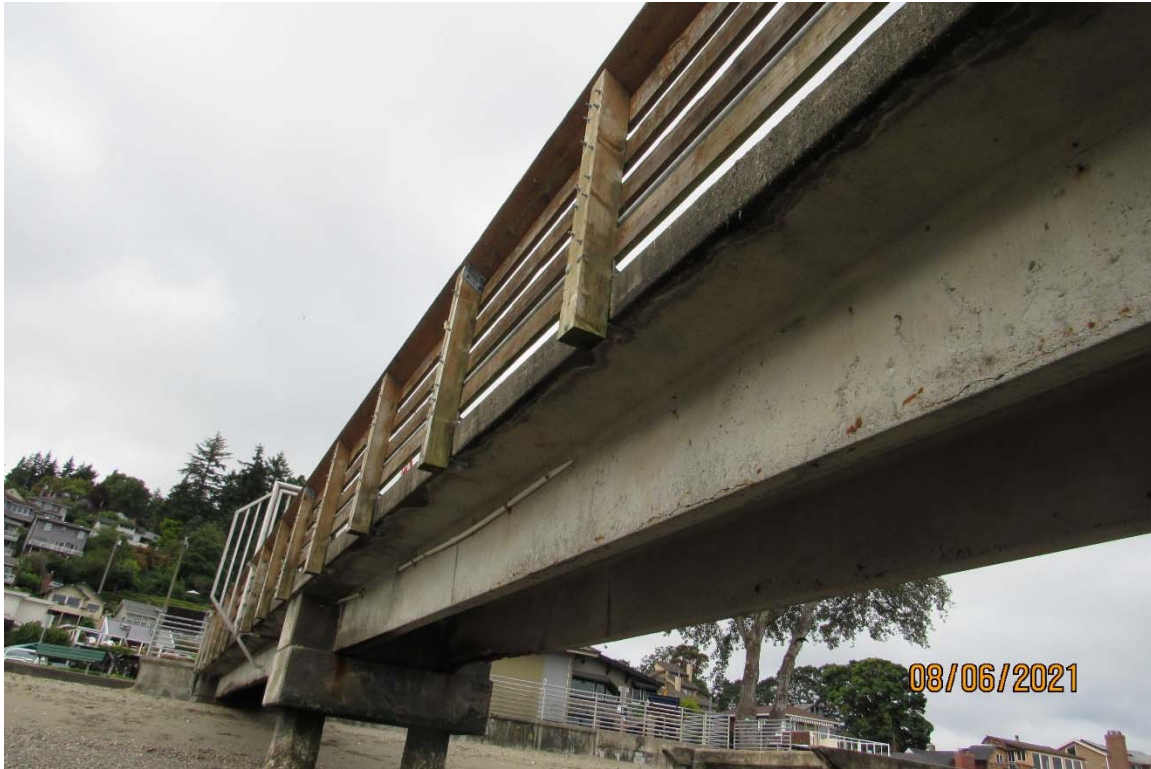
Figure 3.2.3-1. View of typical concrete beam configuration, Span 2 shown, looking south.

Recommendations: It is recommended that the concrete beams be replaced given the deterioration and failure of the prestressing strands and the condition of the concrete.

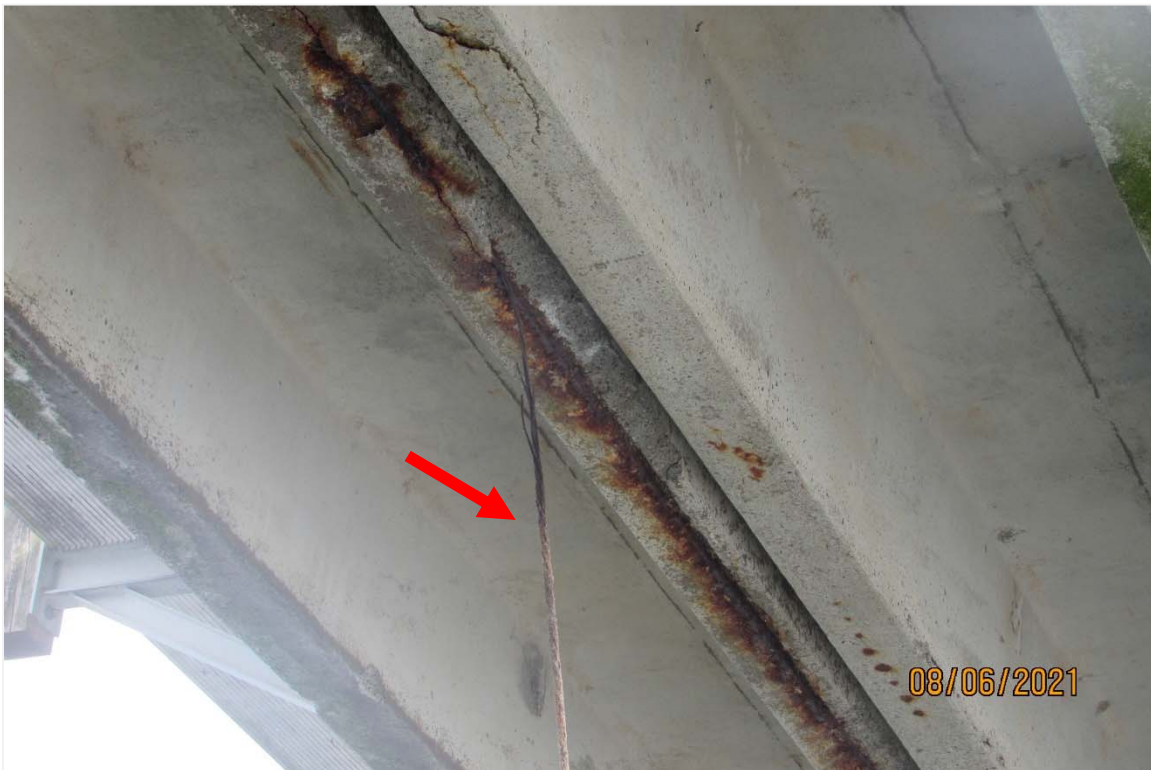
The majority of the defects observed were located from Bents 4 through 10, with sporadic defects in the first four spans. There are three beams that exhibited heavy deterioration and spalling with broken pre-stressing strands, whose locations and defect dimensions are as follows:

Figure 3.2.3-2. View of severe spalling and broken pre-stressing strand in beam, Bent 6.5 shown, looking north.

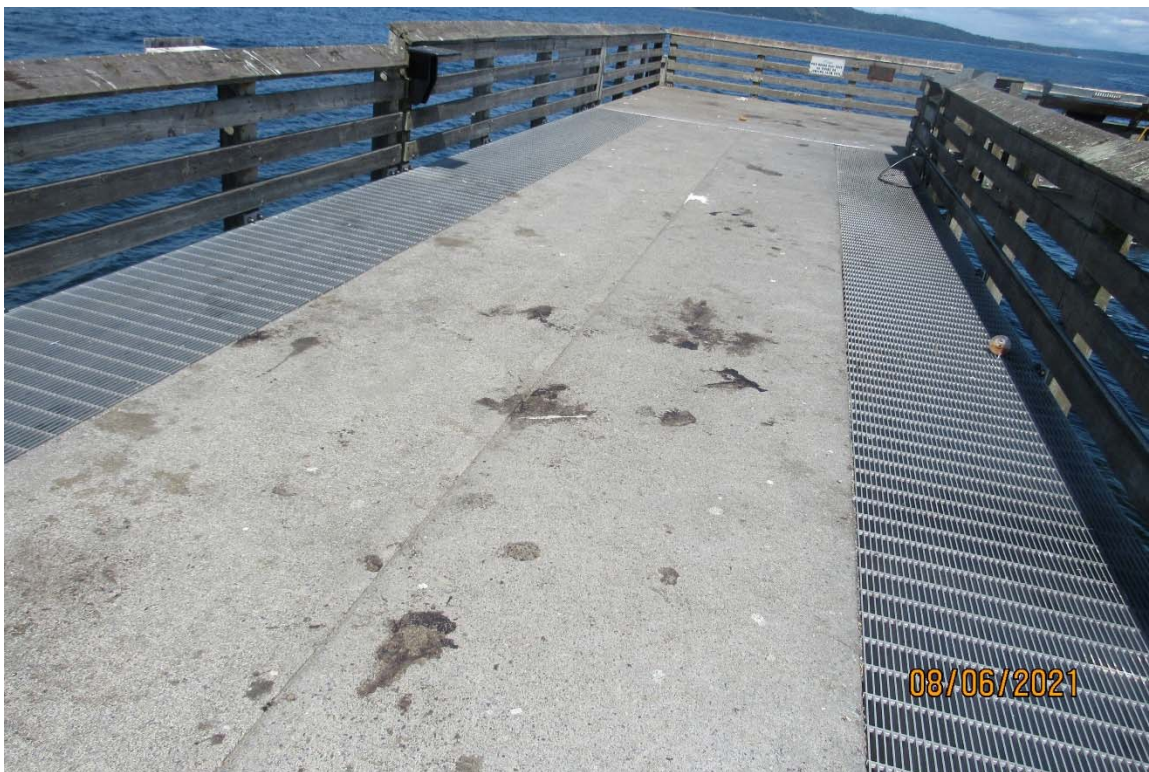
Figure 3.2.4-1. View of typical concrete topping slab and aluminum grating condition, near Bent 6, looking north.

Repair Recommendations: It is recommended that any missing or broken aluminum grating tie-down clips be reinstalled and properly secured.

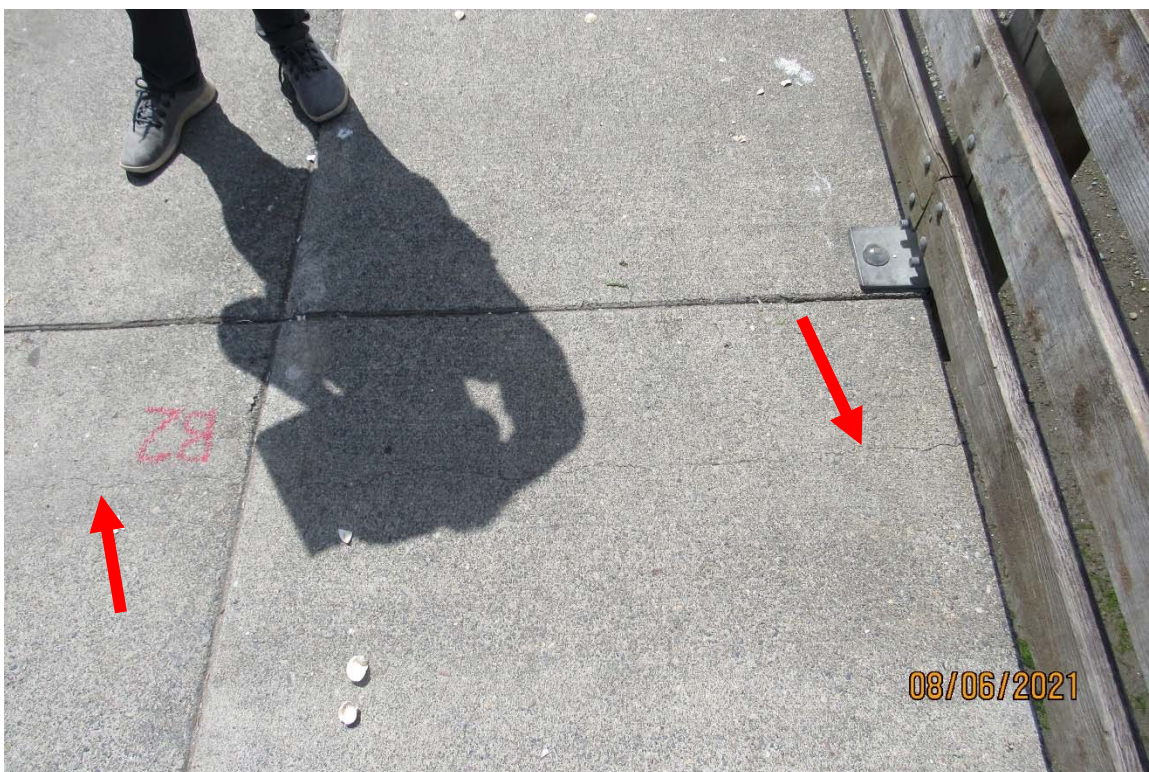
The transverse cracking in the concrete topping slab was located at Bents 2.1, 2.9, and 3.1, and the cracking width at all locations measured approximately 1/32-inch-wide.

Figure 3.2.4-2. View of transverse cracking in the top slab at Bent 2, looking south.

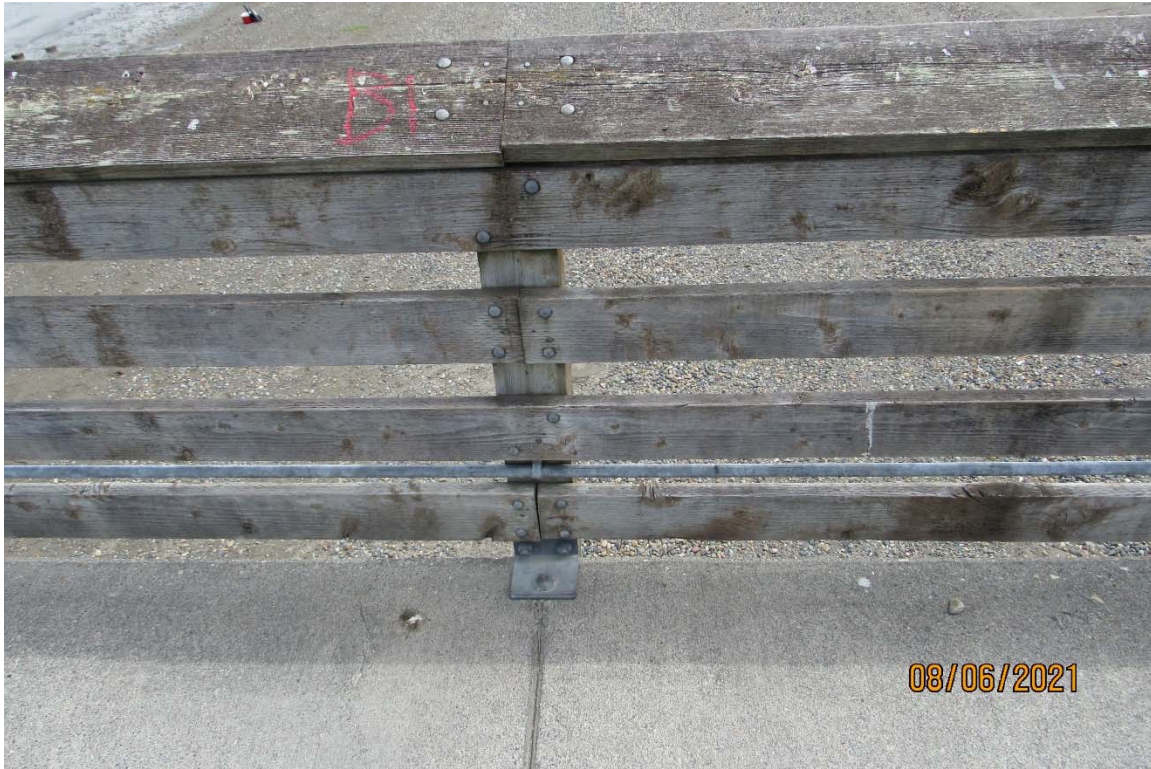
Figure 3.2.5-1. View of the typical timber railing and post condition, near Bent 1 shown, looking east.

Repair Recommendations: It is recommended that the defects in the guardrails be corrected and that the top rail and any damaged or broken timbers be replaced with new timbers.

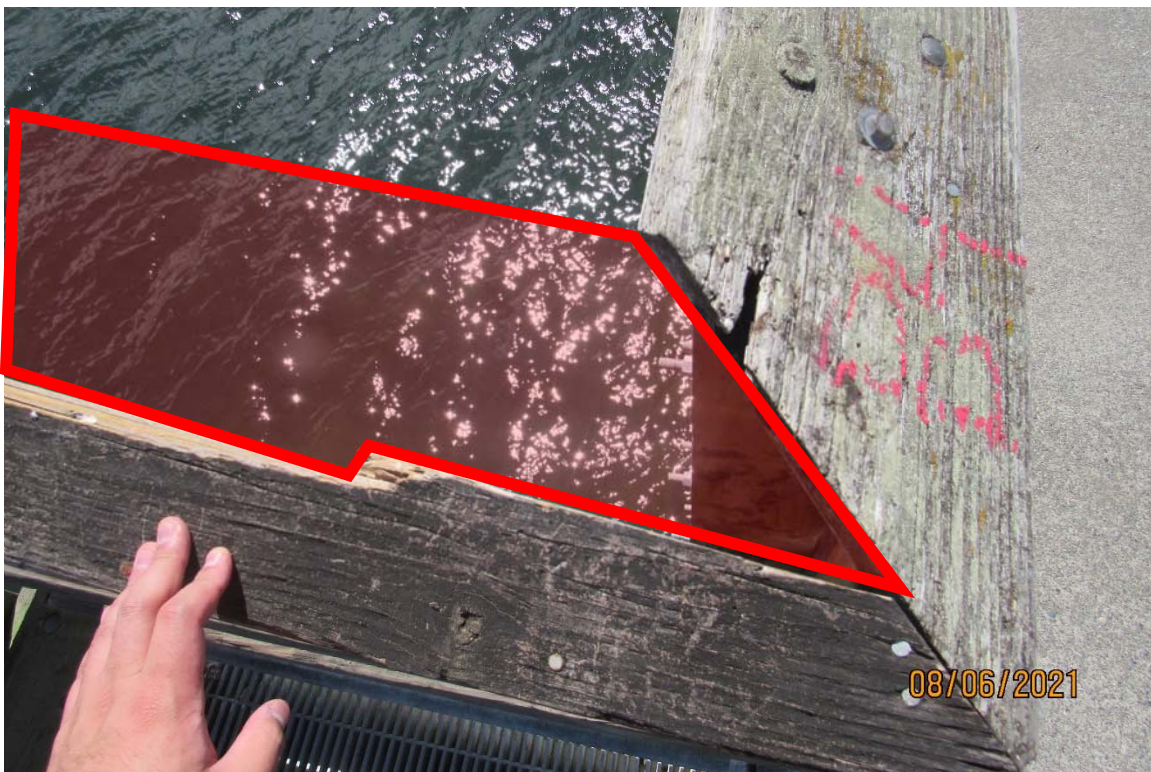
There are 2 areas of decay in the east top railing boards, located at Bent 3.4 and 6.8. Both areas of decay measured up to 2 feet long by full width and up to 1 inch deep. There are 3 missing/broken top railing boards, 1 at the northwest corner of Bent 8, and 2 on the east and west railings at Bent 4, where the aluminum grating starts.

Figure 3.2.5-2. View of the east broken top railing at Bent 4, looking south.

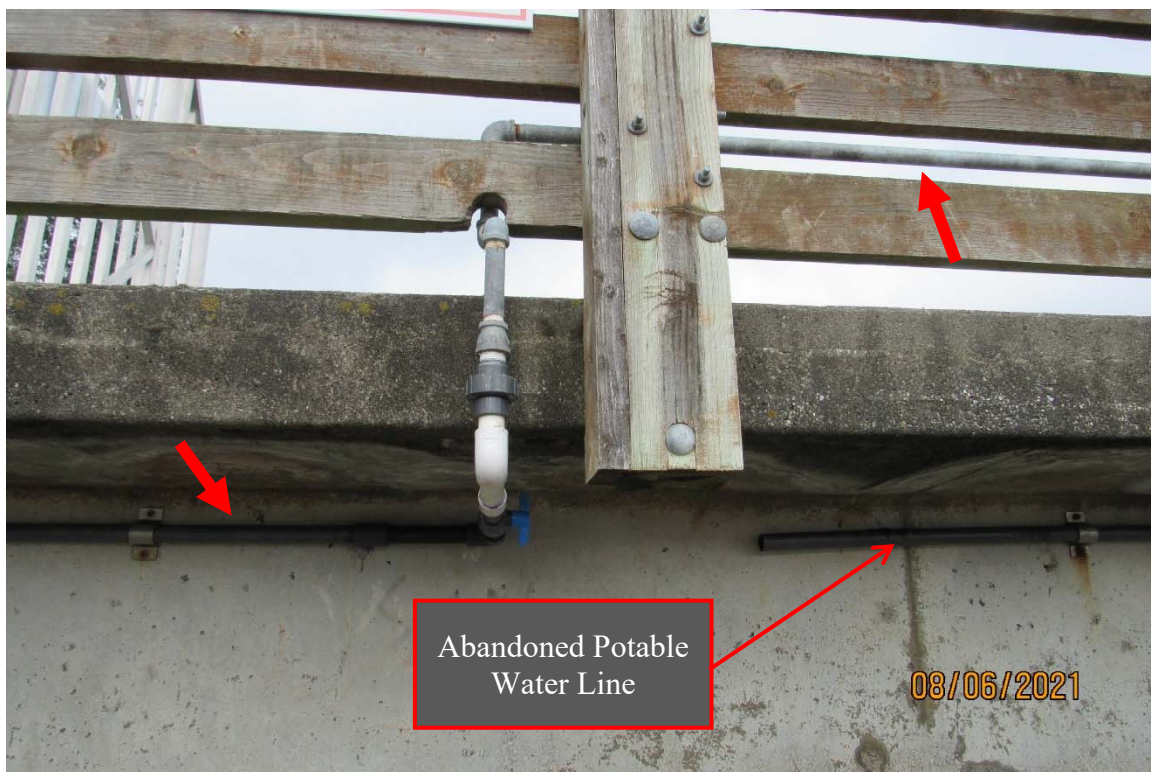
The potable water utility line is composed of the older PVC section and a newer galvanized steel section. Starting at the abutment, the PVC line is attached to the upper half of the web of the east beam and runs to Bent 1, where it ties in with the newer galvanized steel section. The new section turns and heads to the outboard edge of the east rail, where it runs the length of the pier. The abandoned section of the PVC line is still in place but broken in several places.

Figure 3.2.6-1. View of the potable water line and the abandoned utility line typical condition, looking west.

Also, prior to the pier reopening to the public, it is recommended that the electrical and potable water lines be considered a less of a priority while the pier is closed to the public. The electrical system should be inspected for code compliance and tested by an electrical engineering firm and replaced if necessary. The potable water line be pressure tested and any leakage locations be repaired. The PVC line from shore should be replaced with galvanized or high-density polyethylene (HDPE) piping and the broken hose bib handle replaced.

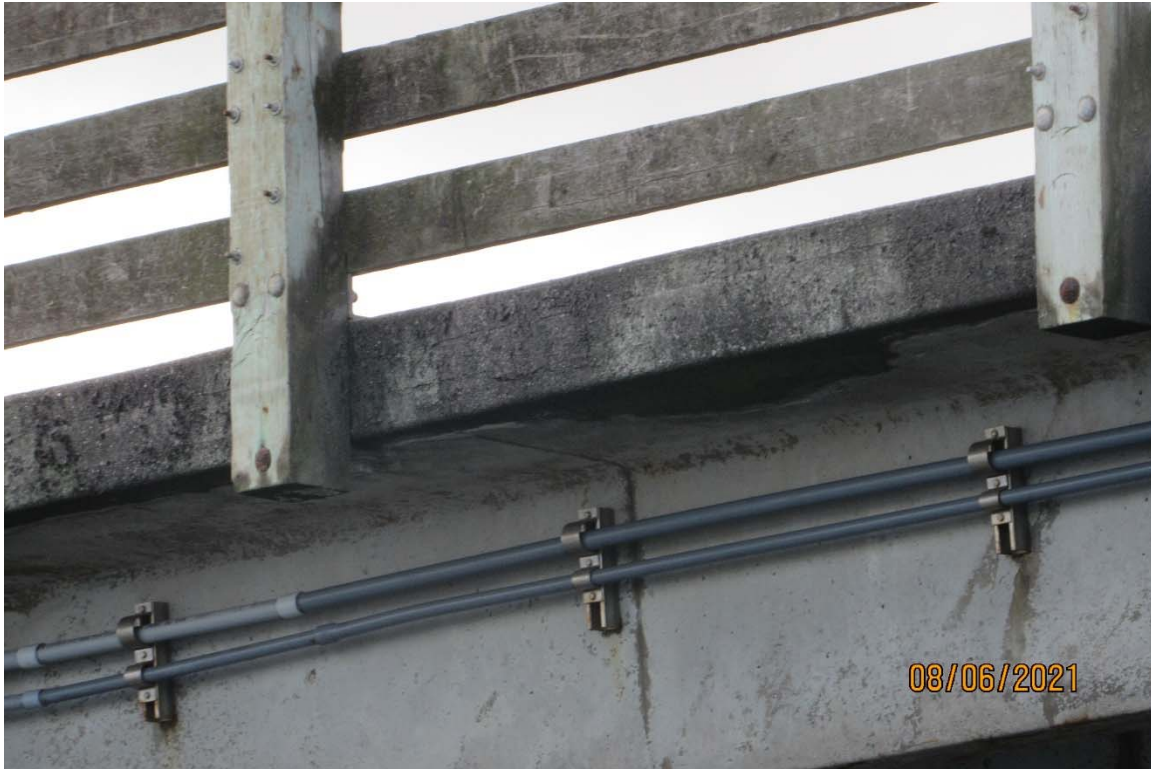
Figure 3.2.5-2. View of the electrical (upper) and navigational (lower) utility line typical condition, looking northeast.

Repair Recommendations: It is recommended that the navigation light systems be high priority. Replacing the current pvc conduit system with a new solar powered lights at the corners of the pier is recommended at this time.

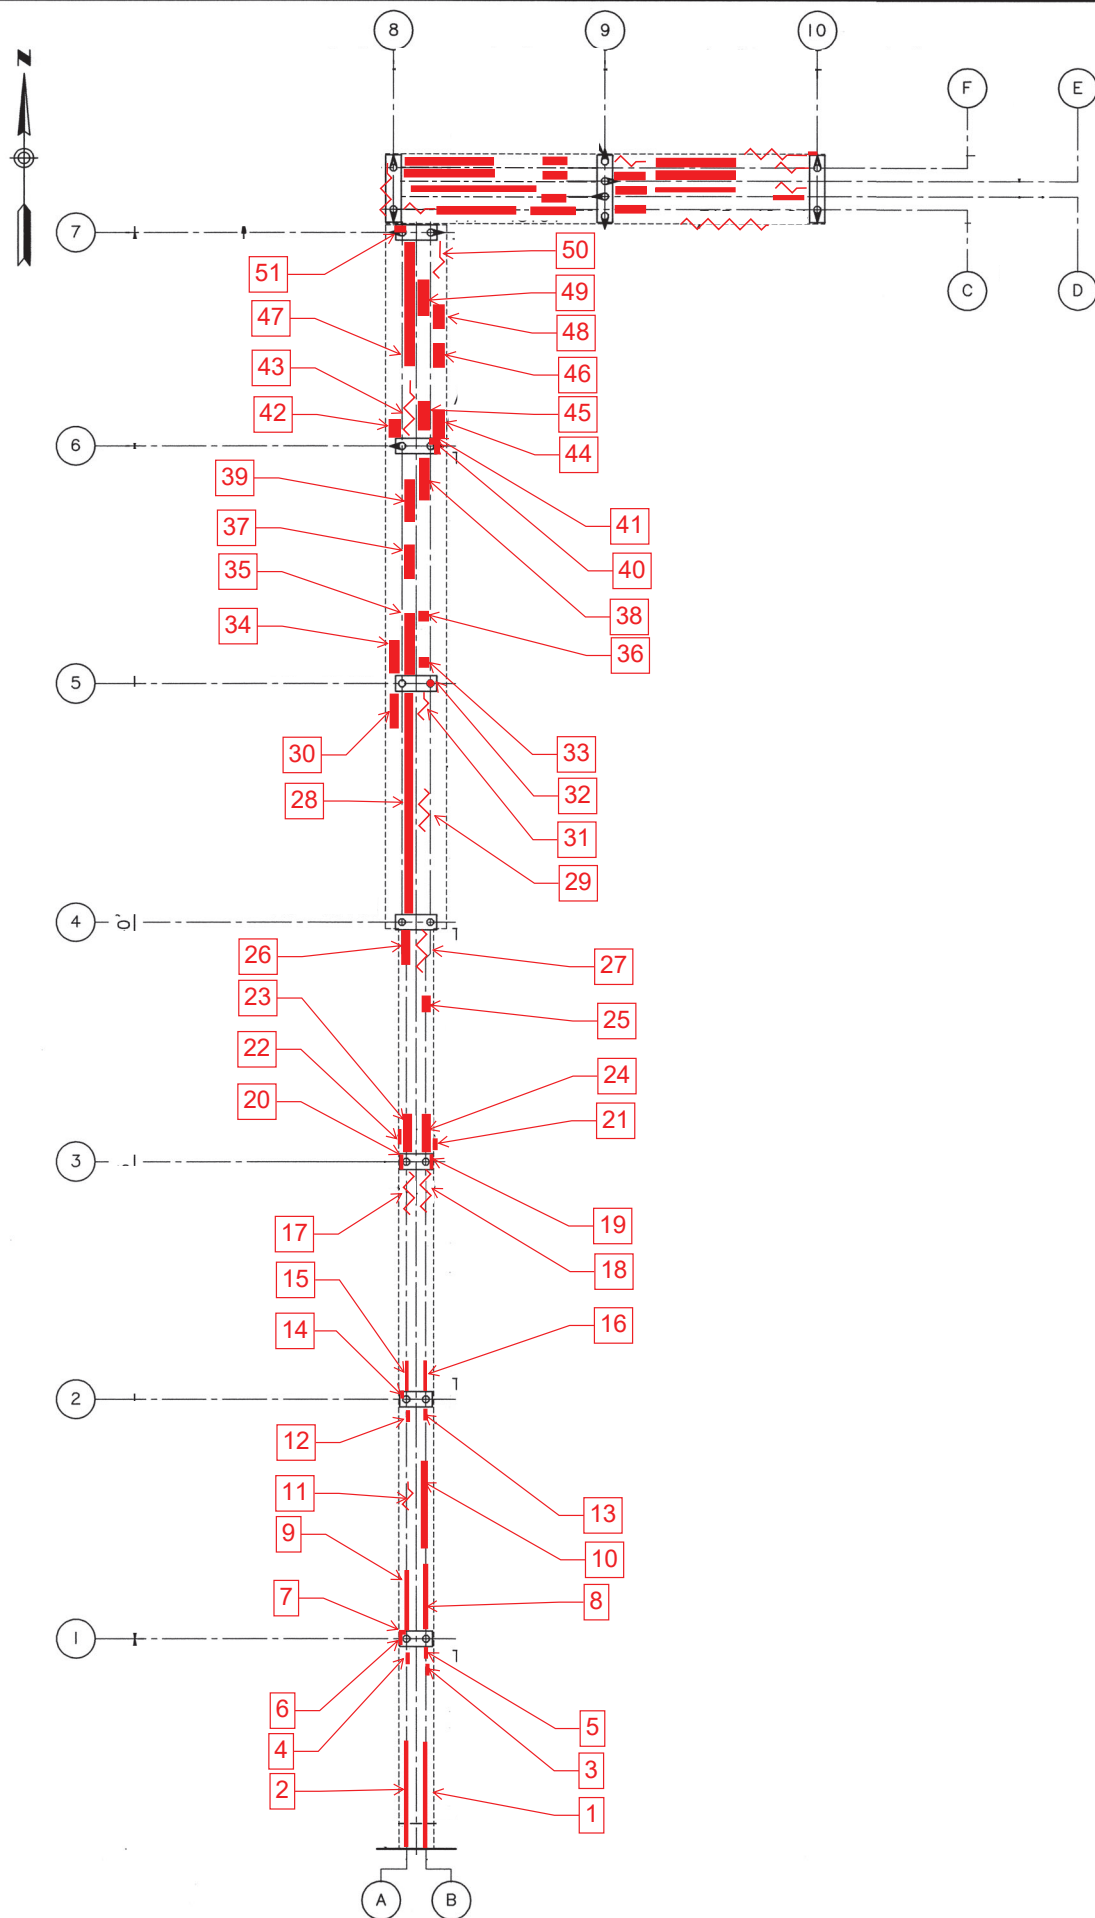
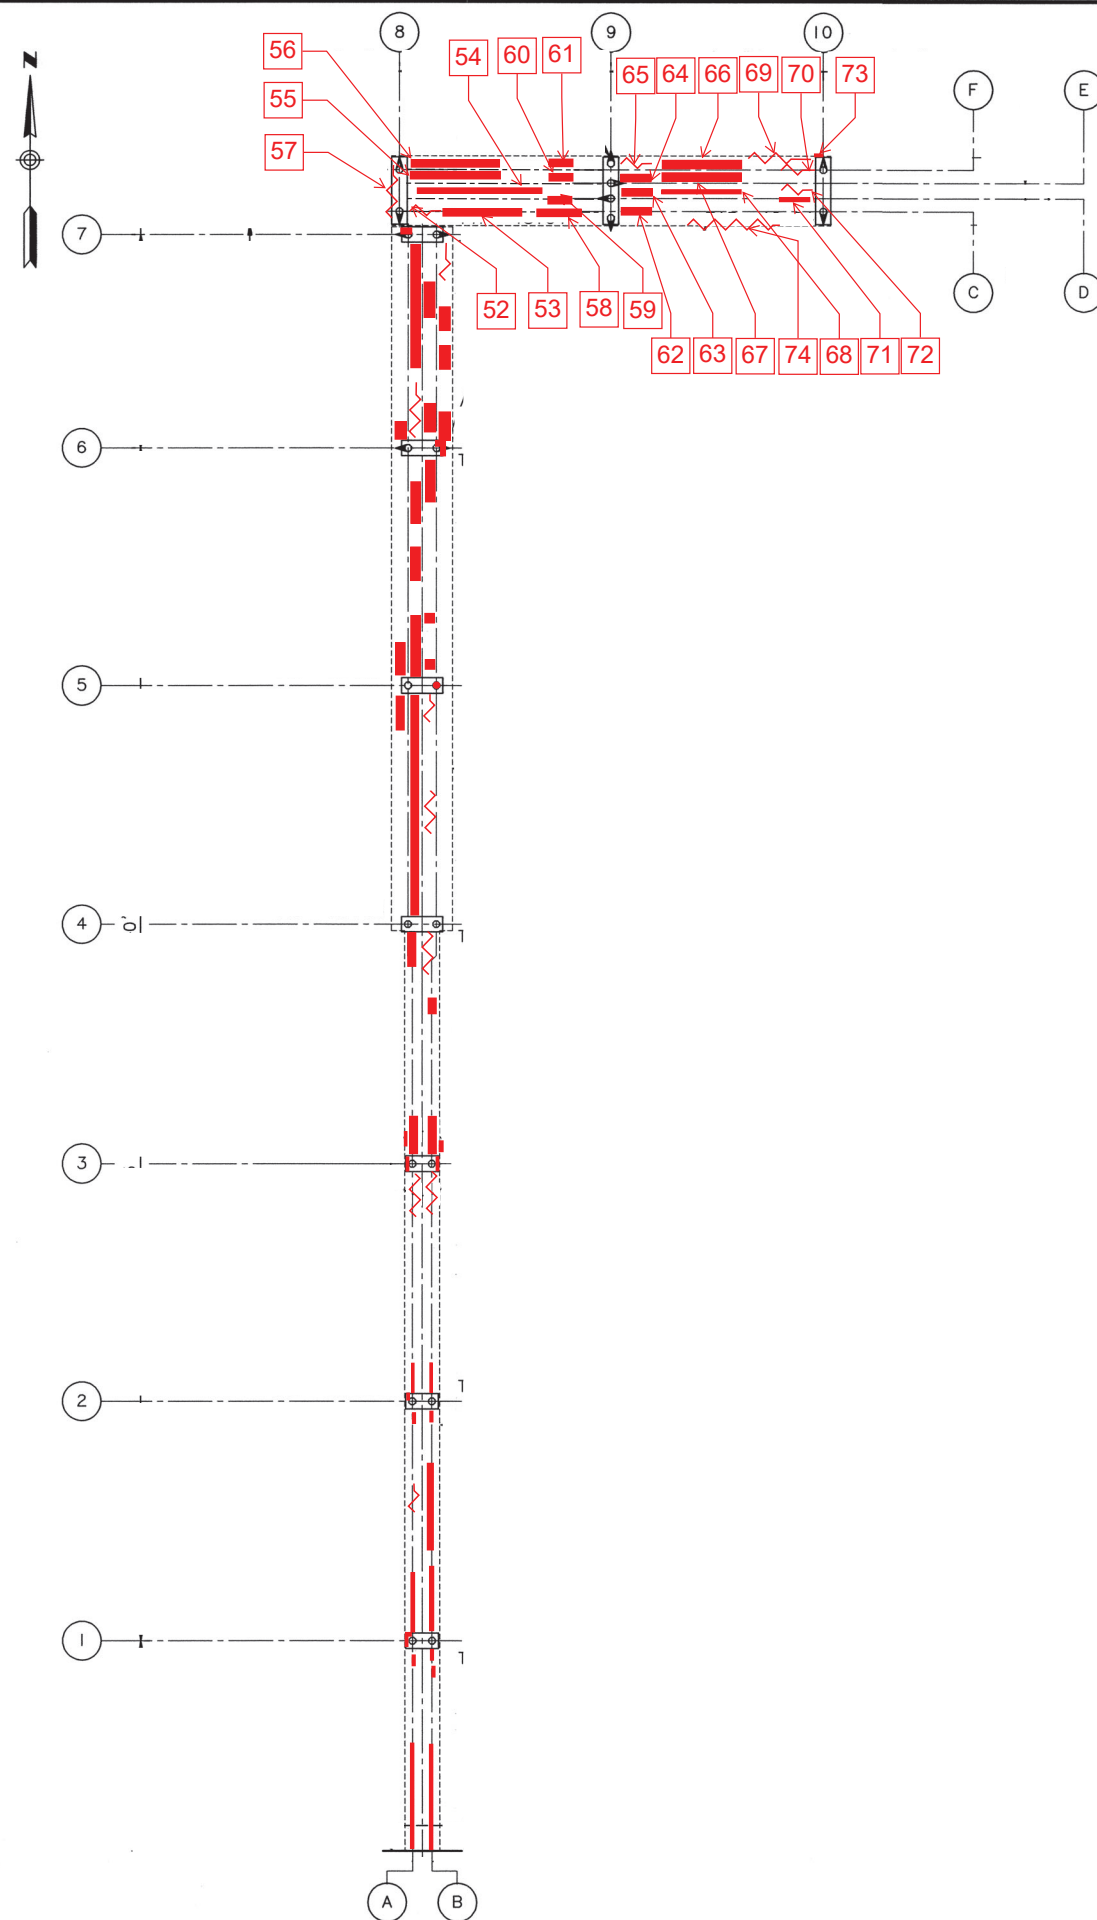
- (1) Multiple edge spalls on the bottom east corner of the web, measuring up to 4'L x 2"W x 2"D with rust staining
- (2) Multiple edge spalls on the bottom east corner of the web, measuring up to 4'L x 2"W x 2"D with rust staining.

- (3) Two spalls on the east face of the web, measuring 1'L x 4"W x 1/2"D with exposed bars
- (4) Two spalls on the east face of the web, each measuring 1'L x 4"W x 1/2"D with exposed bars

- (48) Closed corrosion spalling on the bottom face of the outside web, measuring 2'L x 4"W
- (49) Closed corrosion spalling on the bottom face of the inside web, measuring 3'L x 4"W

- (50) Crack on the bottom face of the inside web, measuring 4'L x 1/4"W
- (51) Rust staining on the bottom of the pile cap, area measuring 1'L x 1'W

- (52) Cracking on the bottom face of the outboard web, measuring 5'L x 1/4"W
- (53) Closed corrosion spalling on the bottom face of the outboard web, measuring 24'L x 5" W

- (54) Closed corrosion spalling and cracking up to 1/8"W on the bottom of the top flange, measuring 24'L x 8"W
- (55) Closed corrosion spalling on the bottom face of the inboard web, measuring 24'L x 5"W

- (71) Rust staining in the north face of the inboard web, measuring 3'L x 3"W
- (72) Longitudinal cracking in the bottom of the top flange, measuring 3'L x 1/16"W

- (73) Vertical crack on the north face of the pile cap, measuring 1'L x 1/8"W
- (74) Longitudinal cracking on the vertical face of the top flange, measuring 10'L x 1/8"W

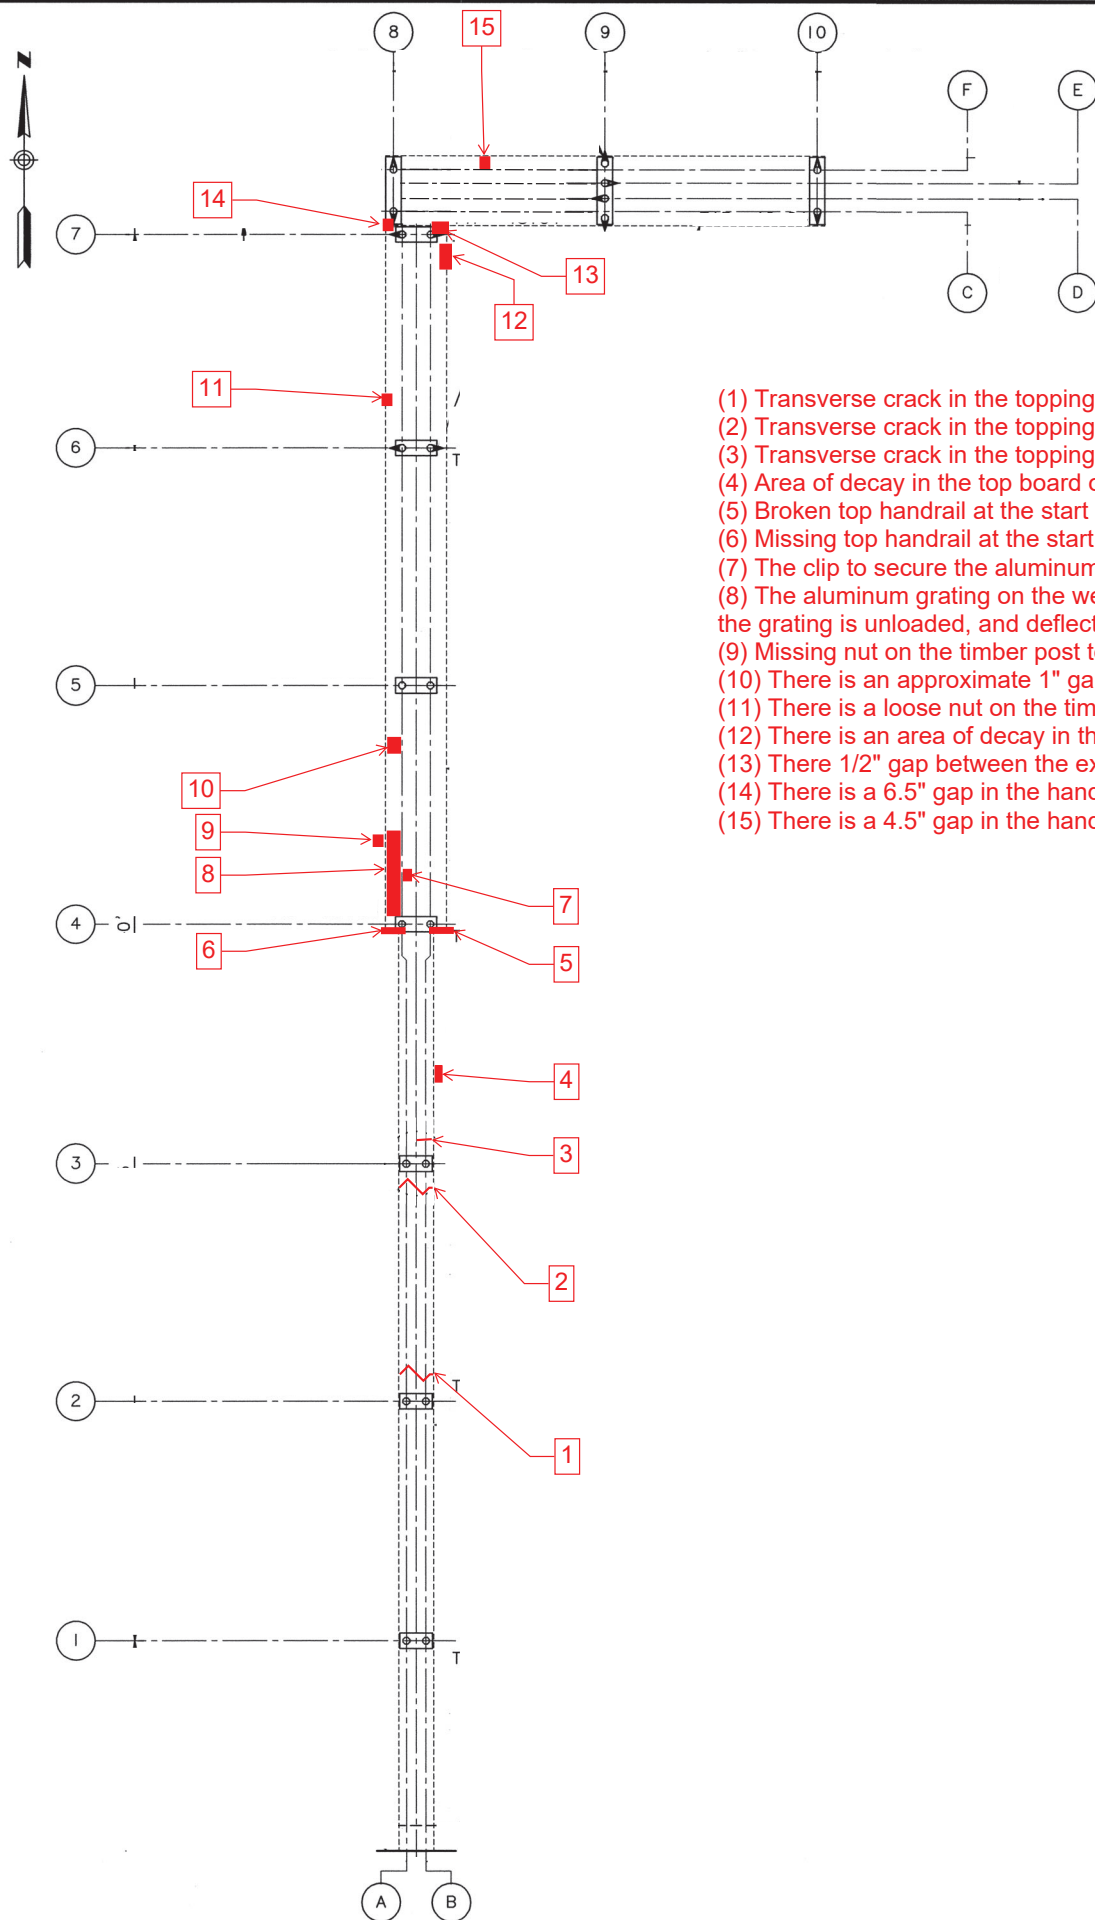
- (1) Transverse crack in the topping slab, measuring 8'L x 1/32" W
- (2) Transverse crack in the topping slab, measuring 8'L x 1/32" W
- (3) Transverse crack in the topping slab, measuring 4'L x 1/32" W

- (4) Area of decay in the top board of the east handrail, area measured 2'L x 6"W x 1/2"D
- (5) Broken top handrail at the start of the aluminum grating section, measuring 3'L x 12"W

- (15) There is a 4.5" gap in the handrail between the timber posts on the north handrail

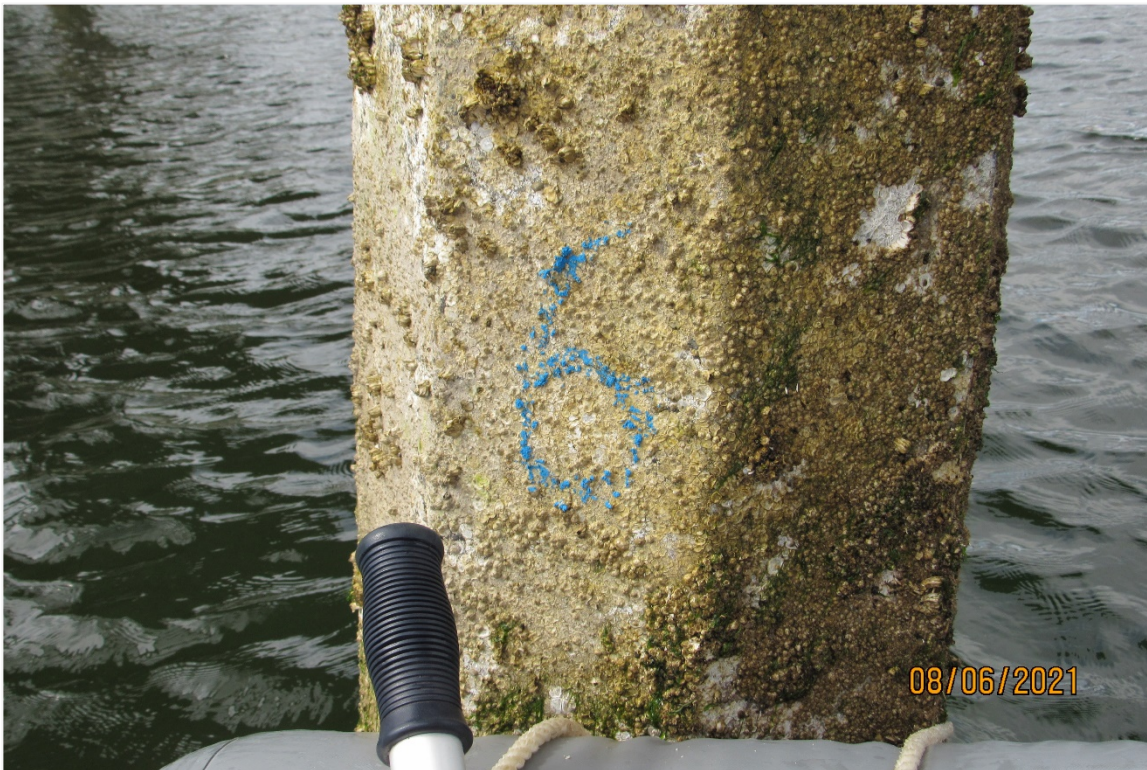
Photograph 3 – View of marine growth on the precast prestressed concrete pile, Pile 6;B shown, looking southwest

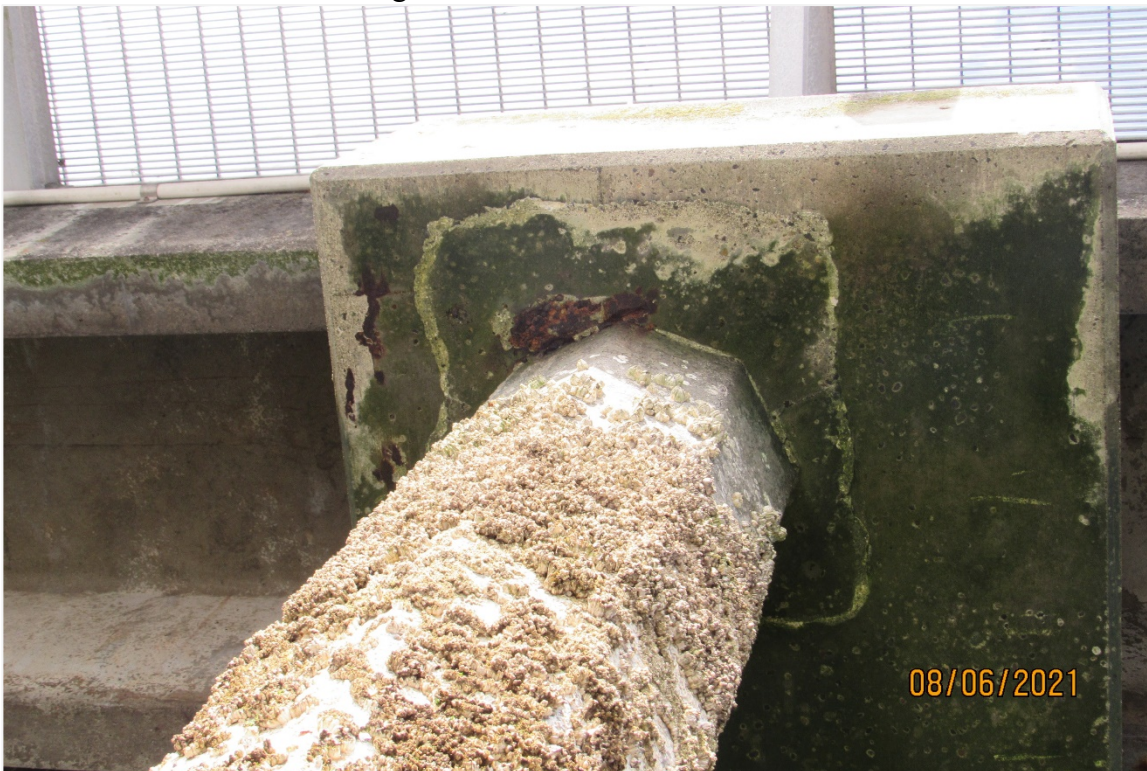
Condition Assessment: There was only 1 defect observed on the pre-stressed piles, which was a vertical crack at Pile 5:B. The pile exhibited a vertical crack on its southeast face, extending from the top of the pile down approximately 2 feet and measuring up to 1/32 inches wide.

Photograph 4 – View of the typical concrete pile condition, Pile 5;B shown, looking west

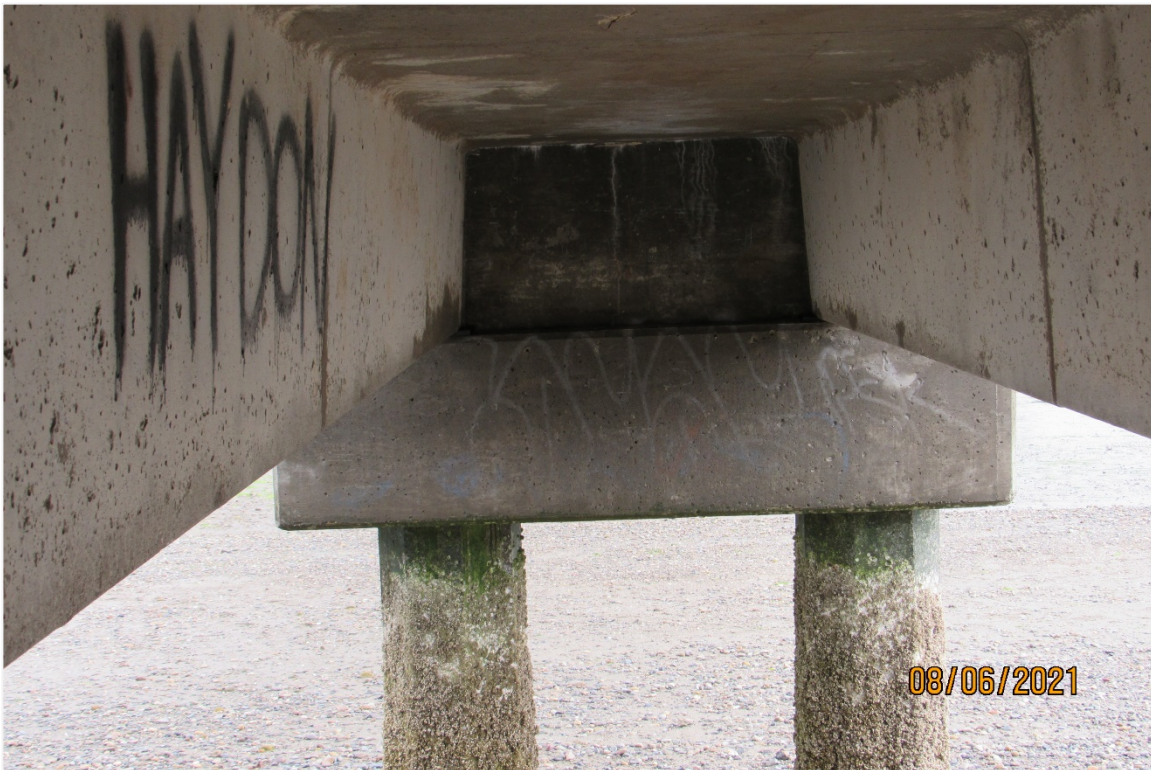
Photograph 5 – View of the typical concrete pile cap condition, Bent 1 pile cap shown, looking north

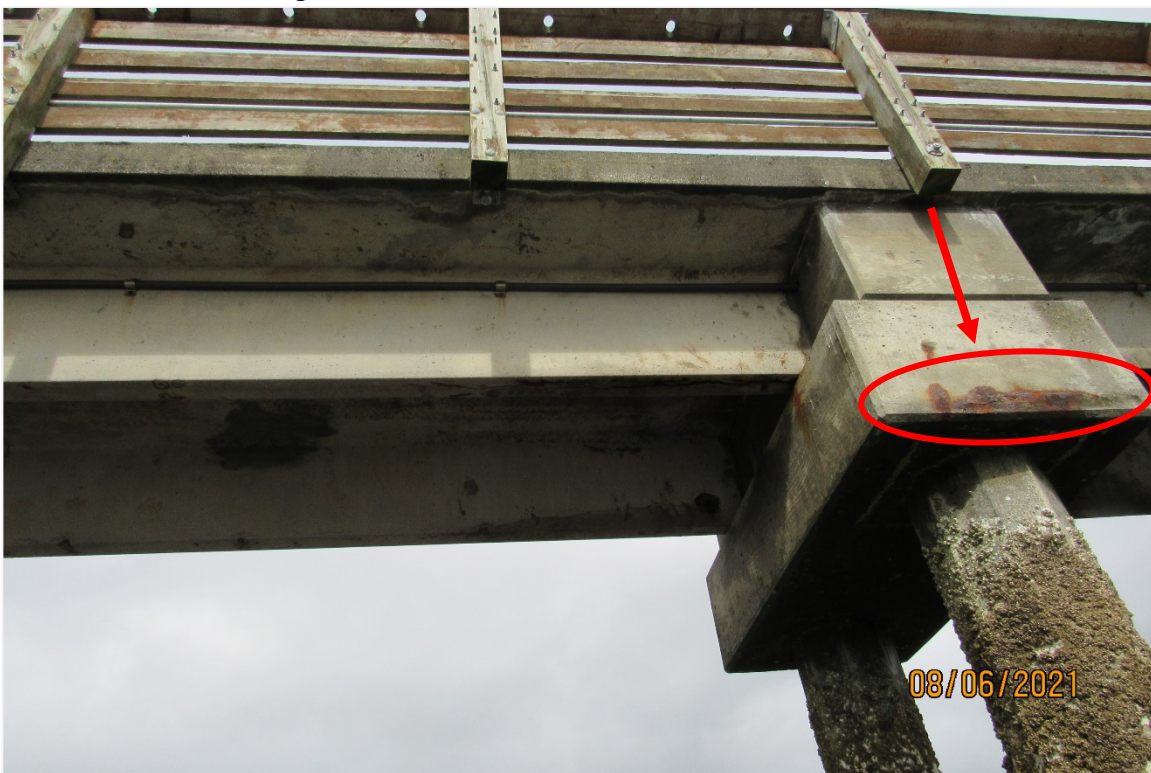
Photograph 6 – View of the rust staining typical condition, Bent 3 pile cap shown, looking west
