DASH POINT PARK

Pier Condition Assessment

Tacoma, Washington

September 2021

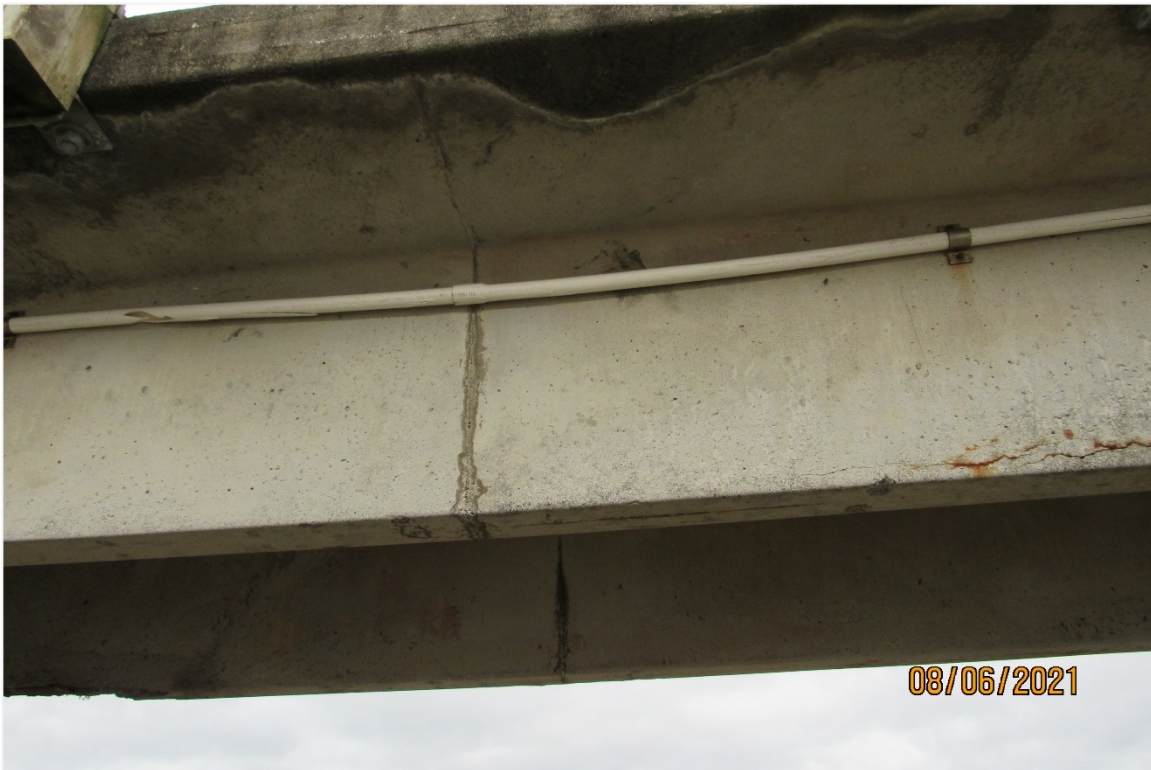
Photograph 7 – View of the typical beam condition, near Bent 1.5 shown, looking west

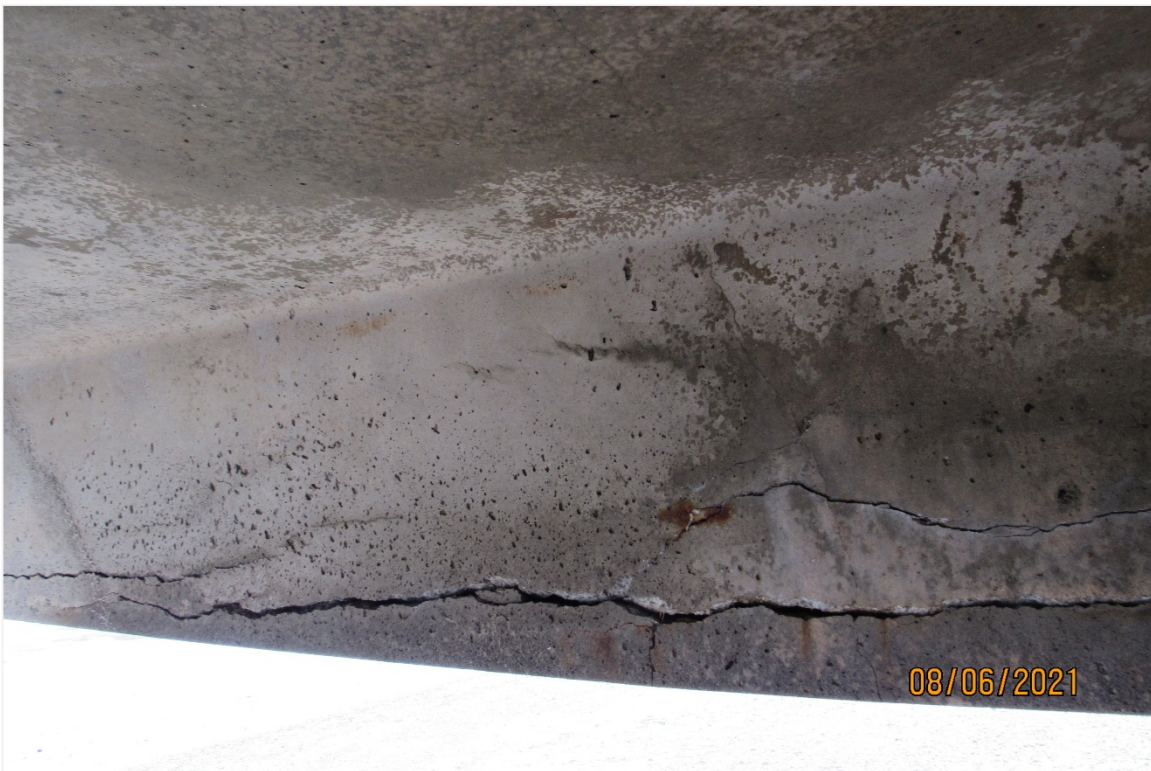
Photograph 8 – View of a typical closed corrosion spall, near Bent 1 shown, looking east

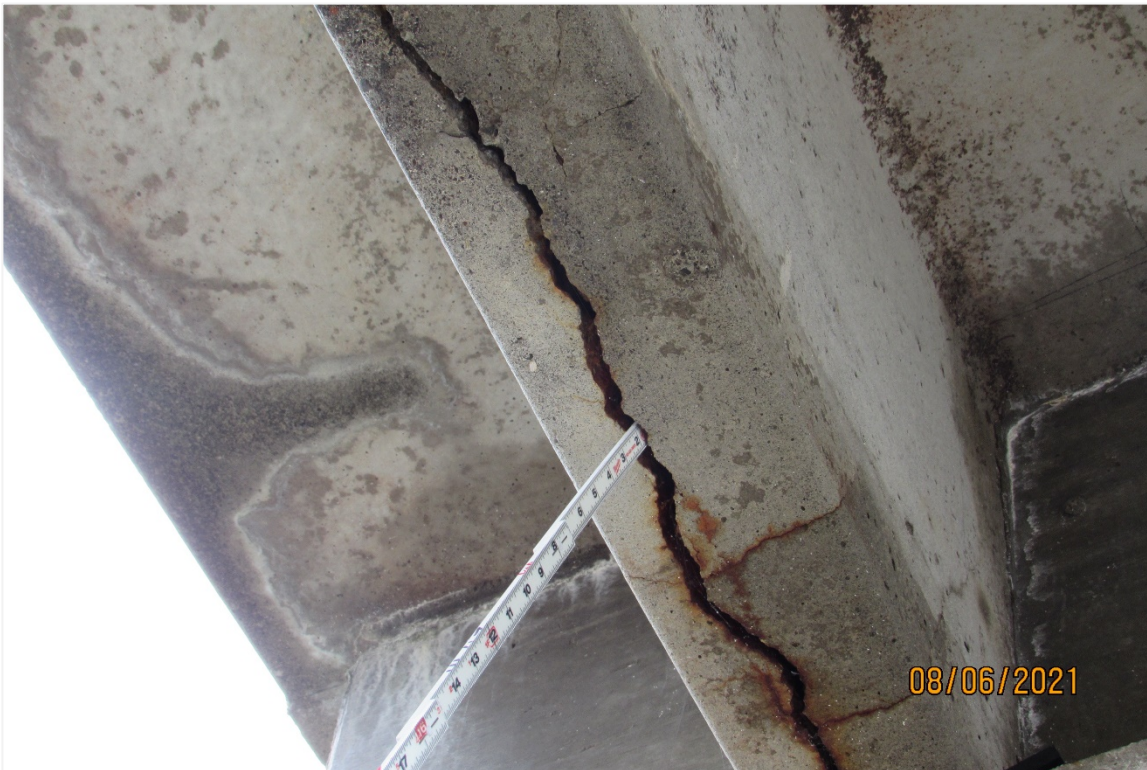
Photograph 9 – View of a typical crack in the bottom face of the beam web, near Bent 2 shown, looking south

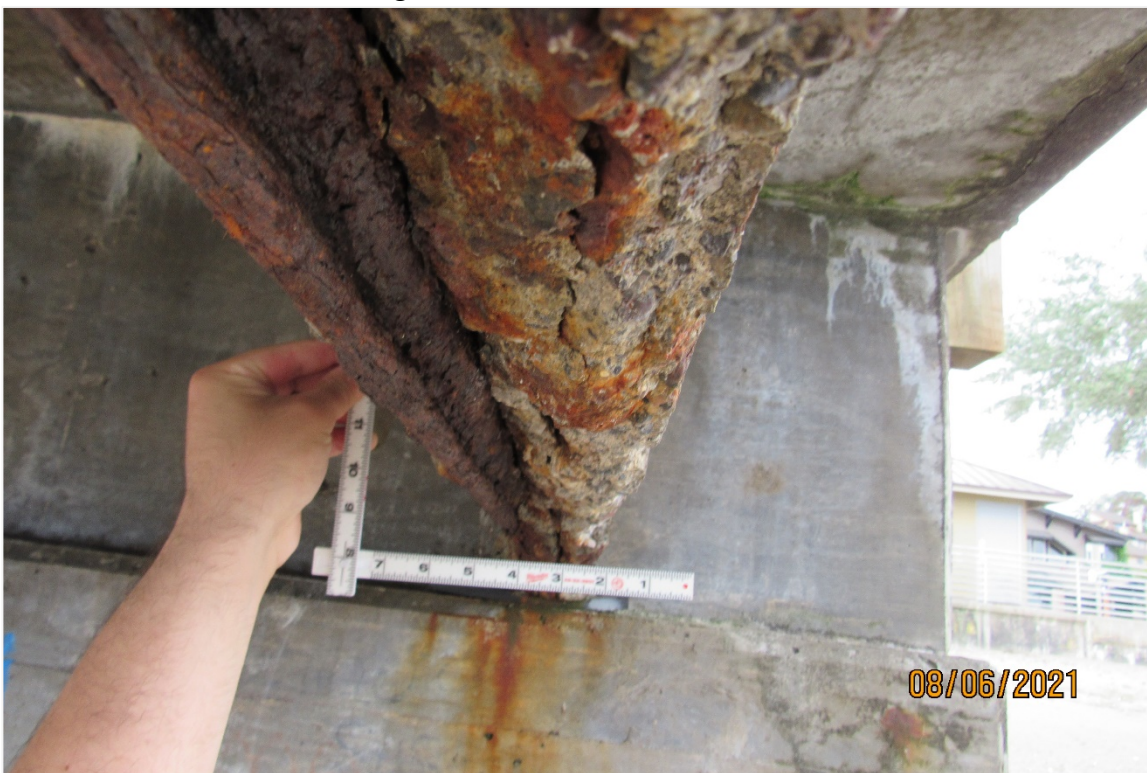
Photograph 10 – View of an open corrosion spall with exposed steel, near Bent 1 shown, looking south

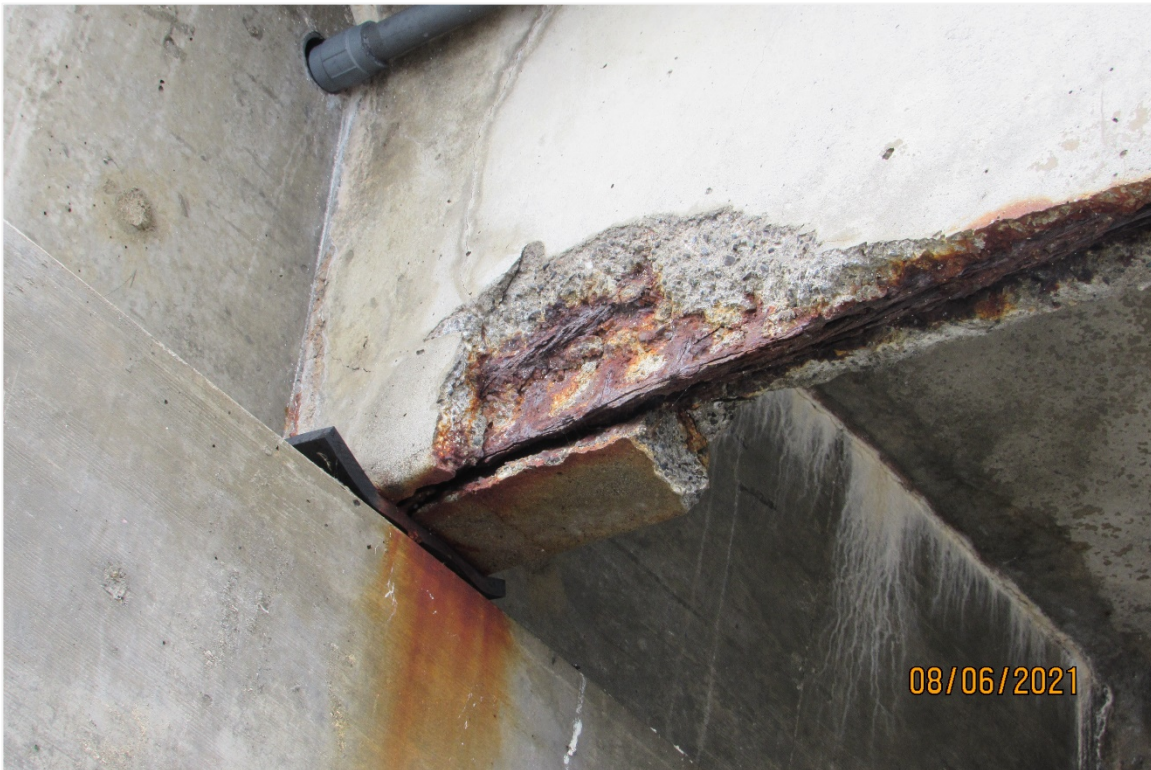
Deterioration is also prevalent throughout the structure near the bearings at each pile cap, typically within the first and last 10 feet of the beams. Spalling and heavy cracking at these locations were observed in the bottom face and extending partly up the sides of the beams

Photograph 11 – View of an open corrosion spall at the bearing, Bent 2N shown, looking southwest

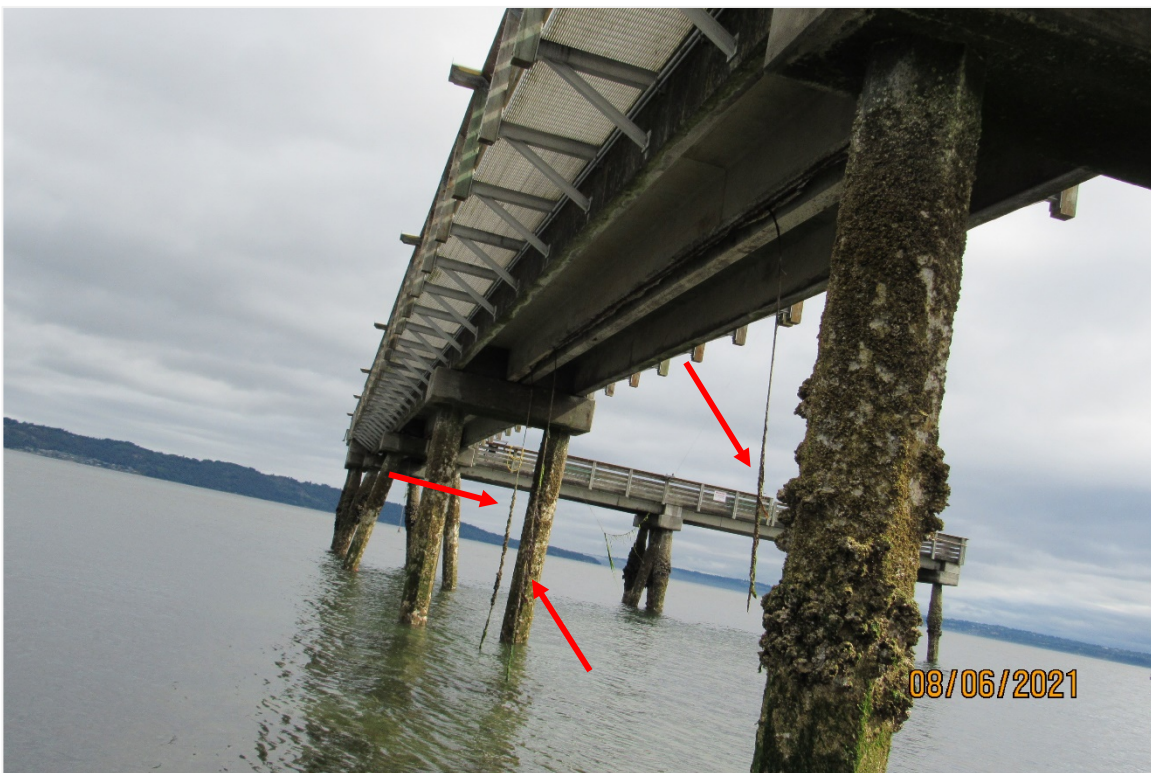
- Bent 4.5, west beam, 54 ft. long by 5 in. wide by 6 in. deep, 3 broken strands
- Bent 5.2, west beam, 12 ft. long by 7 in. wide by 3 in. deep, 2 broken strands
- Bent 6.8, west beam, 30 ft. long by 5 in. wide by 4 in. deep, 3 broken strands

Photograph 12 – View of an open corrosion spall and three broken prestressing strands, Bent 4.5 shown, looking north

Recommendations: It is recommended that the concrete beams be replaced given the deterioration and failure of the prestressing strands and the condition of the concrete.

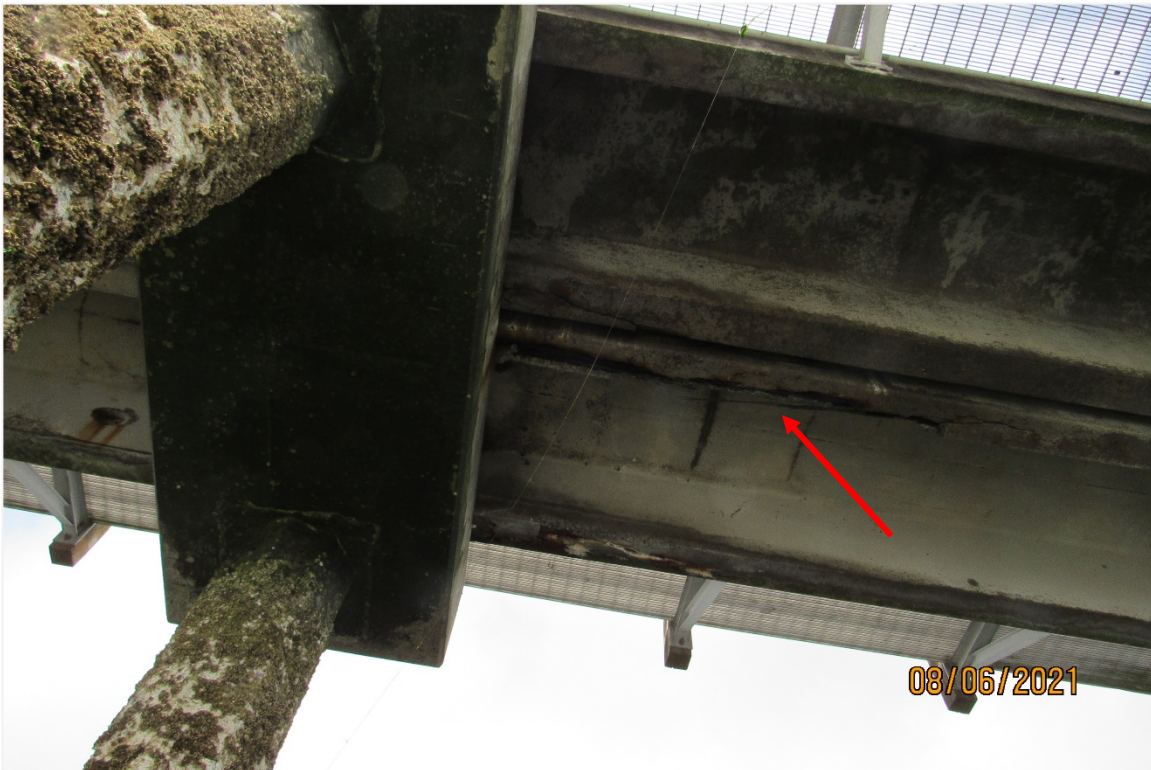
Photograph 13 – View of an open corrosion spall with two broken prestressing strands, Bent 5.2 shown, looking west

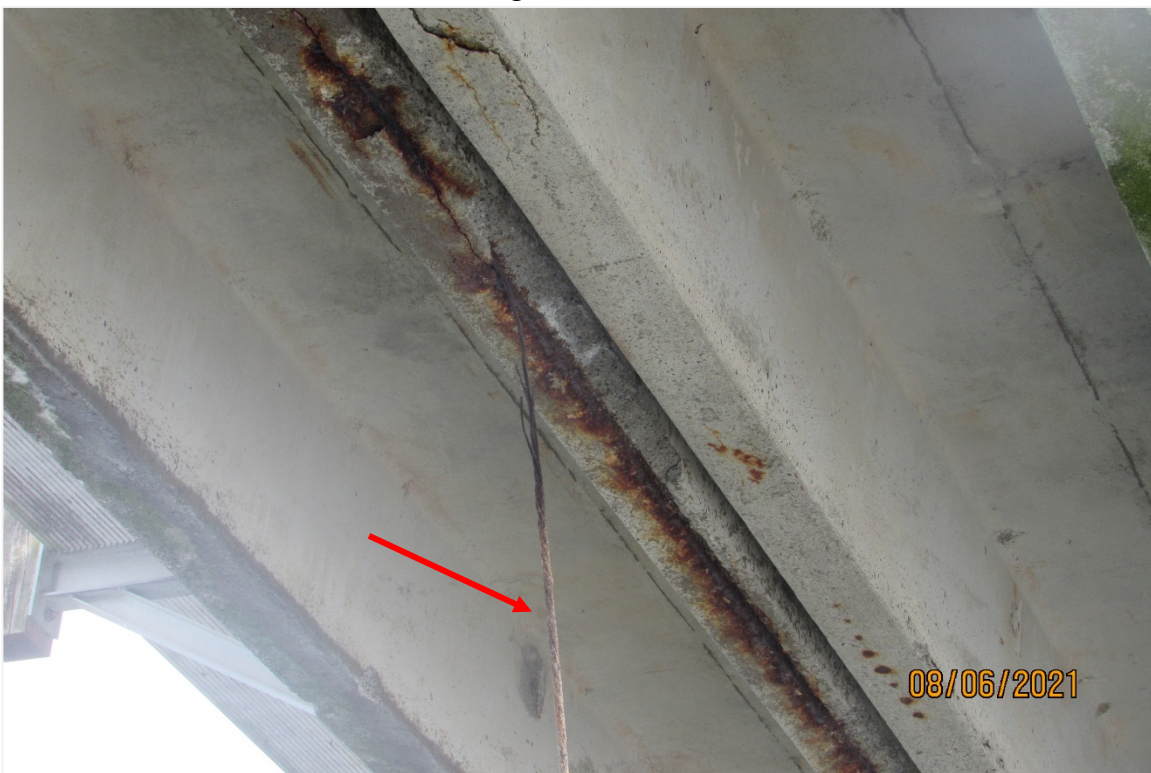
Photograph 14 – View of an open corrosion spall with a broken prestressing strand, Bent 6.8 shown, looking north

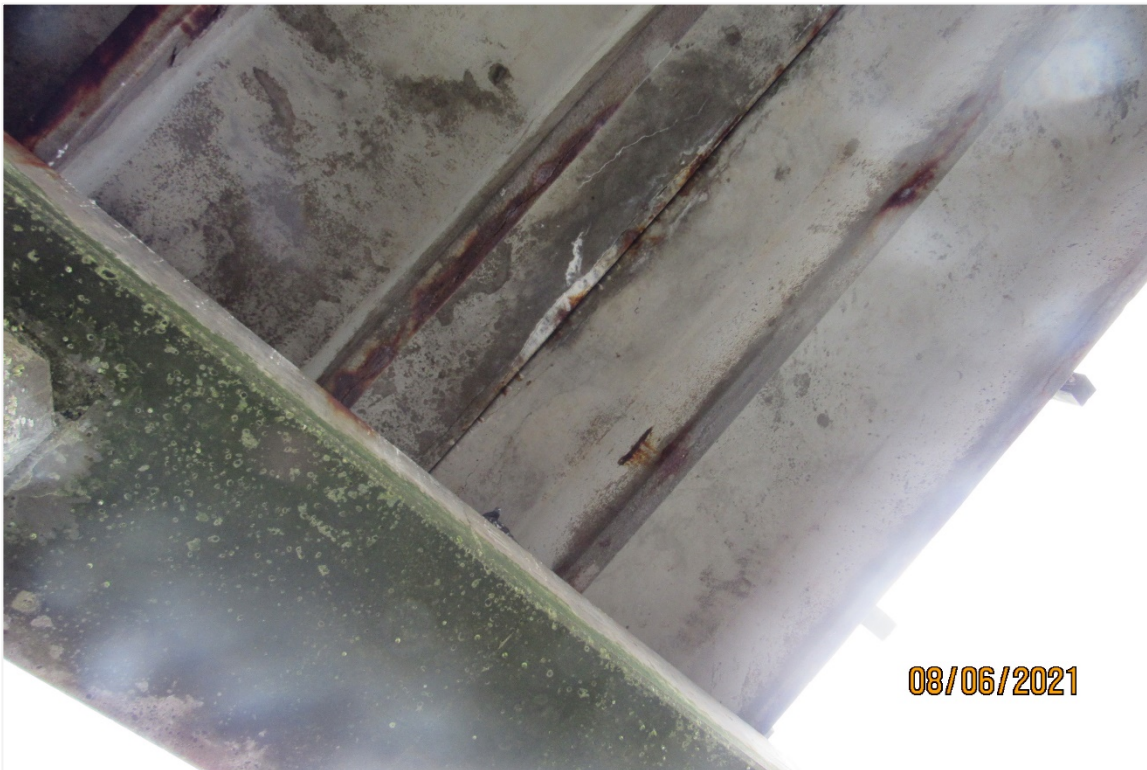
Photograph 15 – View of delamination and staining in the beam top flange, near Bent 8 shown, looking northwest

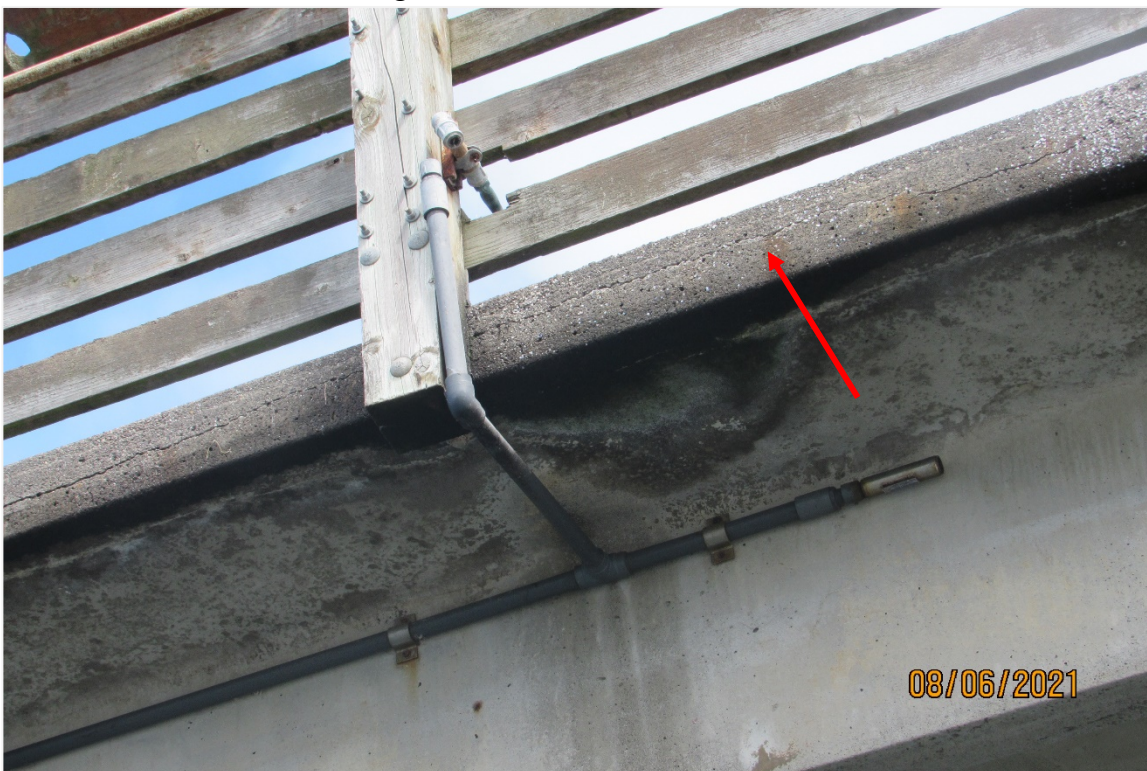
Photograph 16 – View of a longitudinal crack in the beam top flange, near Bent 9 shown, looking north

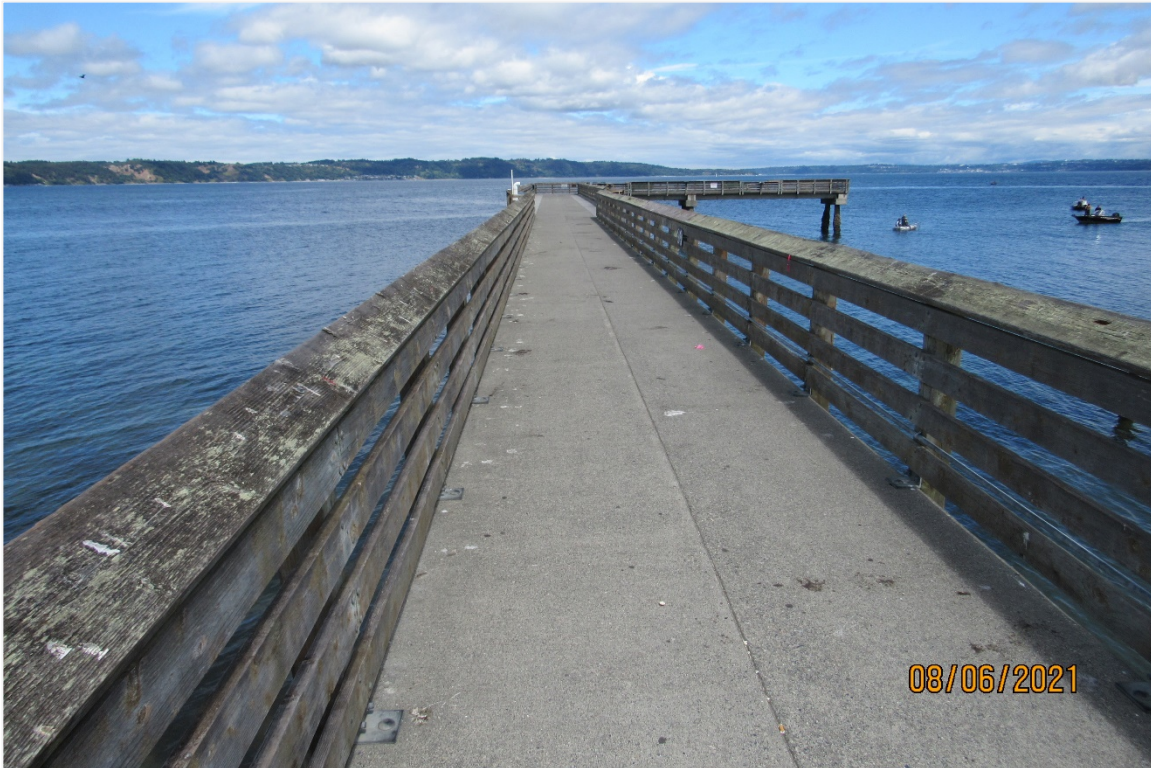
Photograph 17 – View of the typical concrete topping slab condition, near Bent 2 shown, looking north

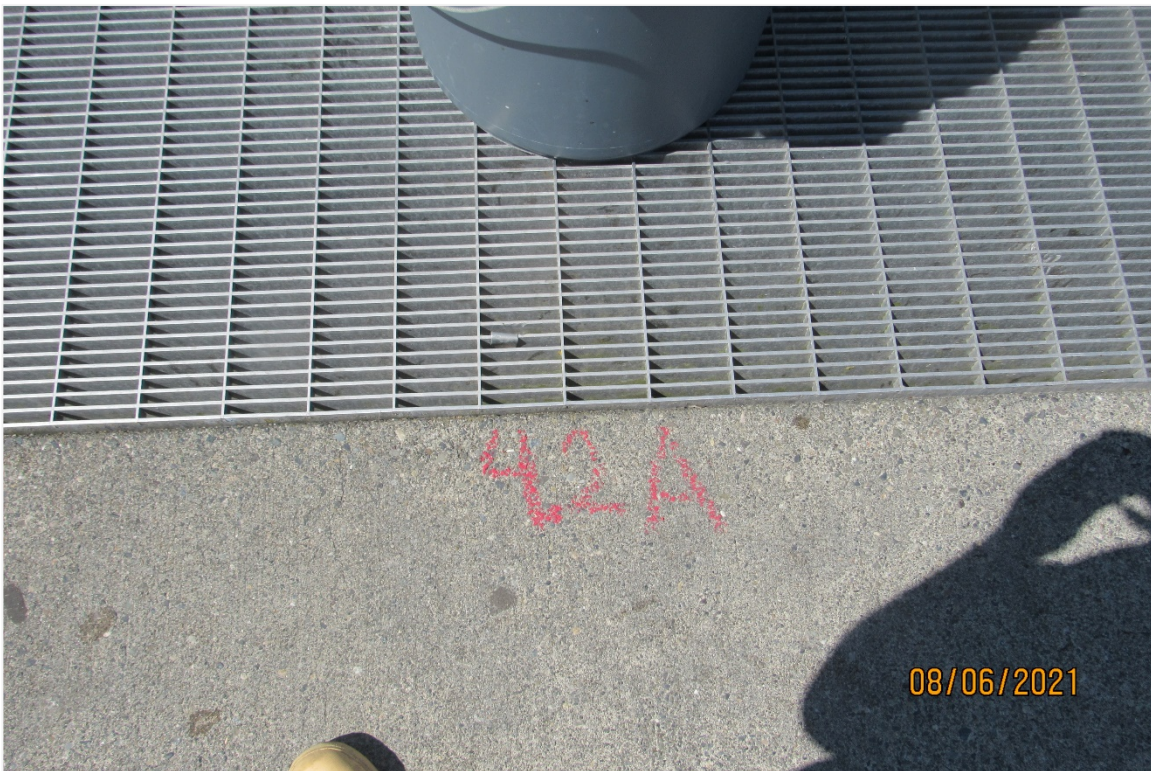
Deflections in the aluminum grating were observed in the west grating at Bents 4.2 and 4.7 and in the east grating at the expansion joint between Bents 7 and 8. Deflections in grating at the aforementioned areas measuring up to 1/2 inch above the topping slab when the grating was unloaded, and 1/4 inch below the topping slab when loaded.

Photograph 18 – View of the typical aluminum grating condition, near Bent 4.2 shown, looking west

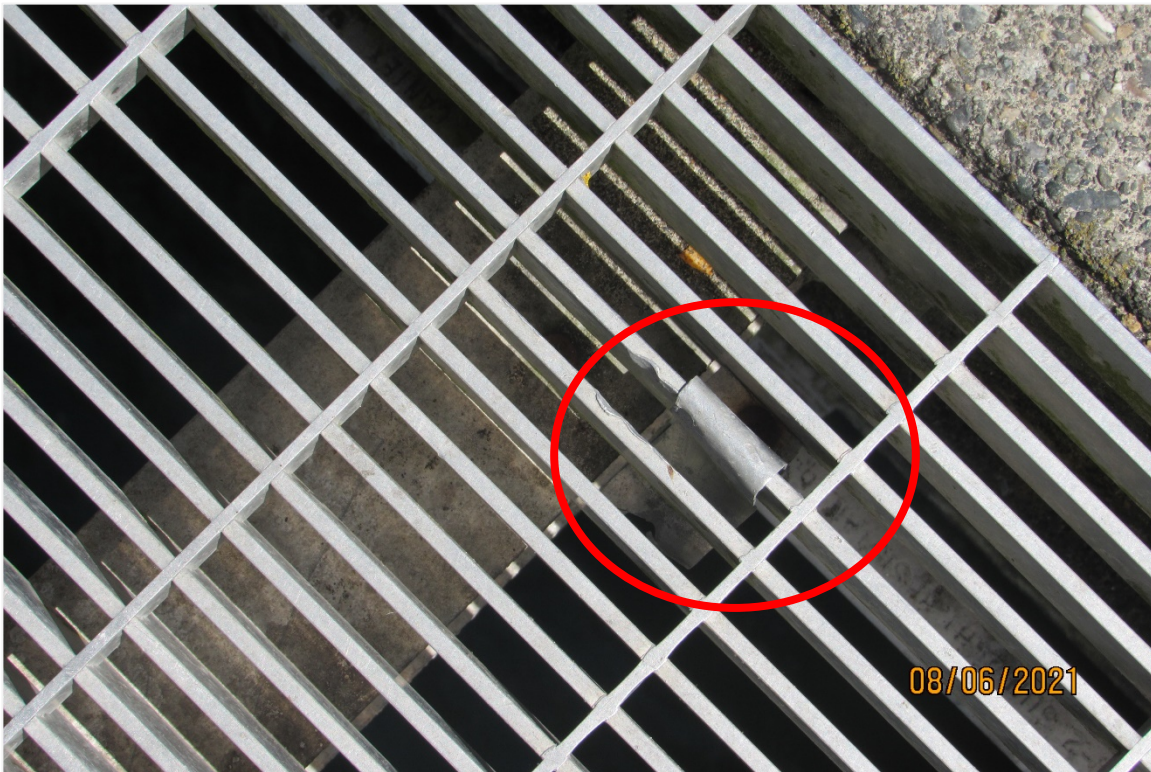
Condition Assessment: There were a total of 7 defects noted on the deck. Defects observed in the deck included 3 transverse cracks (22 ft.) in the concrete topping slab, 3 gaps/deflections in the aluminum grating (36 ft.), and approximately 10% of the aluminum grating clips were broken.

Photograph 19 – View of a typical broken clip that secures the aluminum grating, looking north

Repair Recommendations: It is recommended that any missing or broken aluminum grating tie-down clips be reinstalled and properly secured.

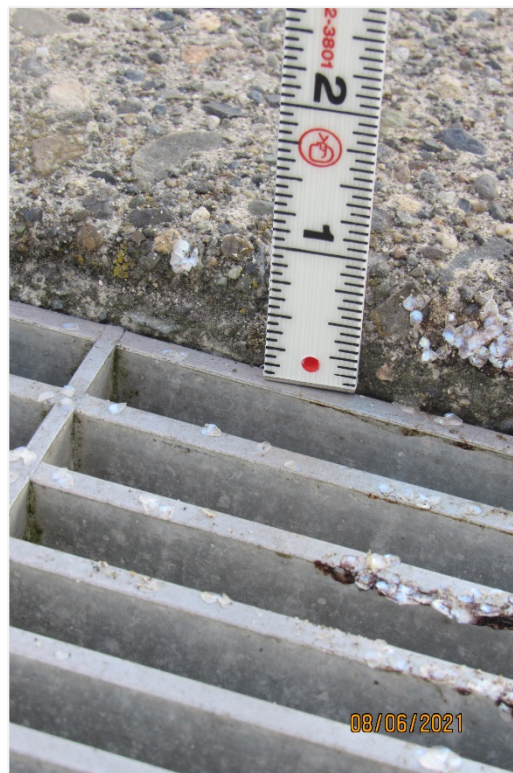
Photograph 20 – View of the misalignment of the aluminum grating and the concrete topping slab, looking east

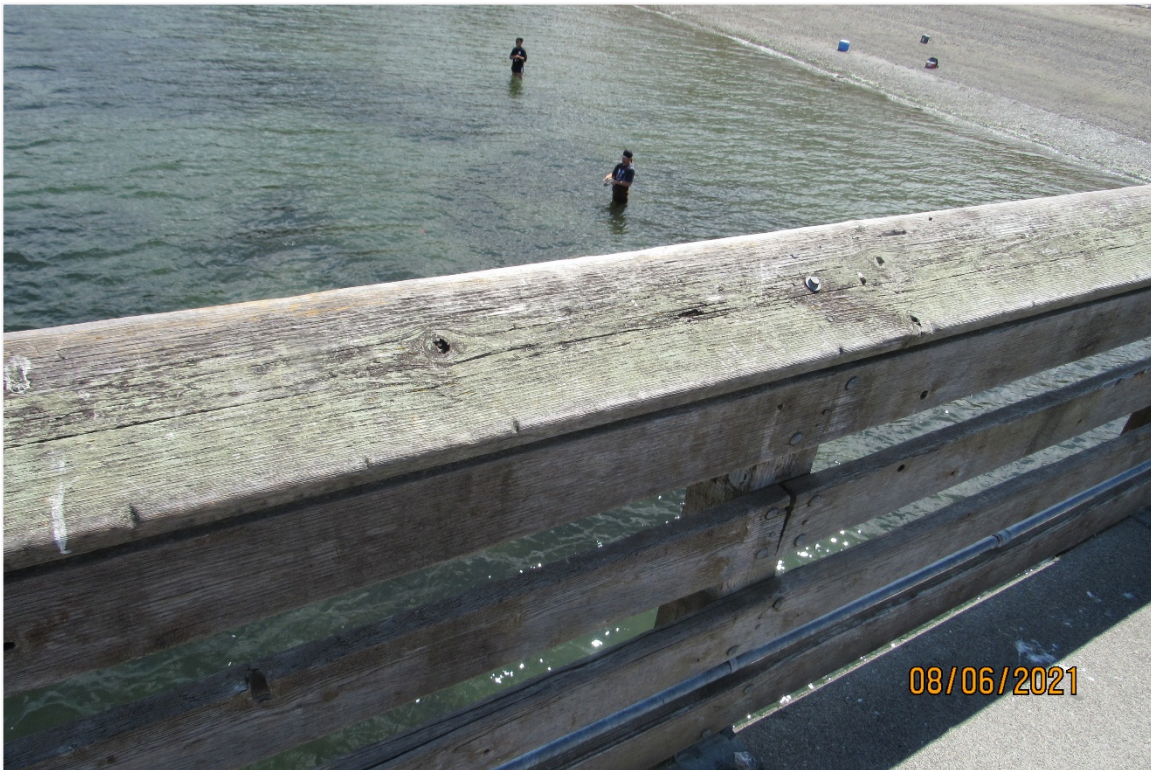
Photograph 21 – View of the typical timber rail condition, looking southeast

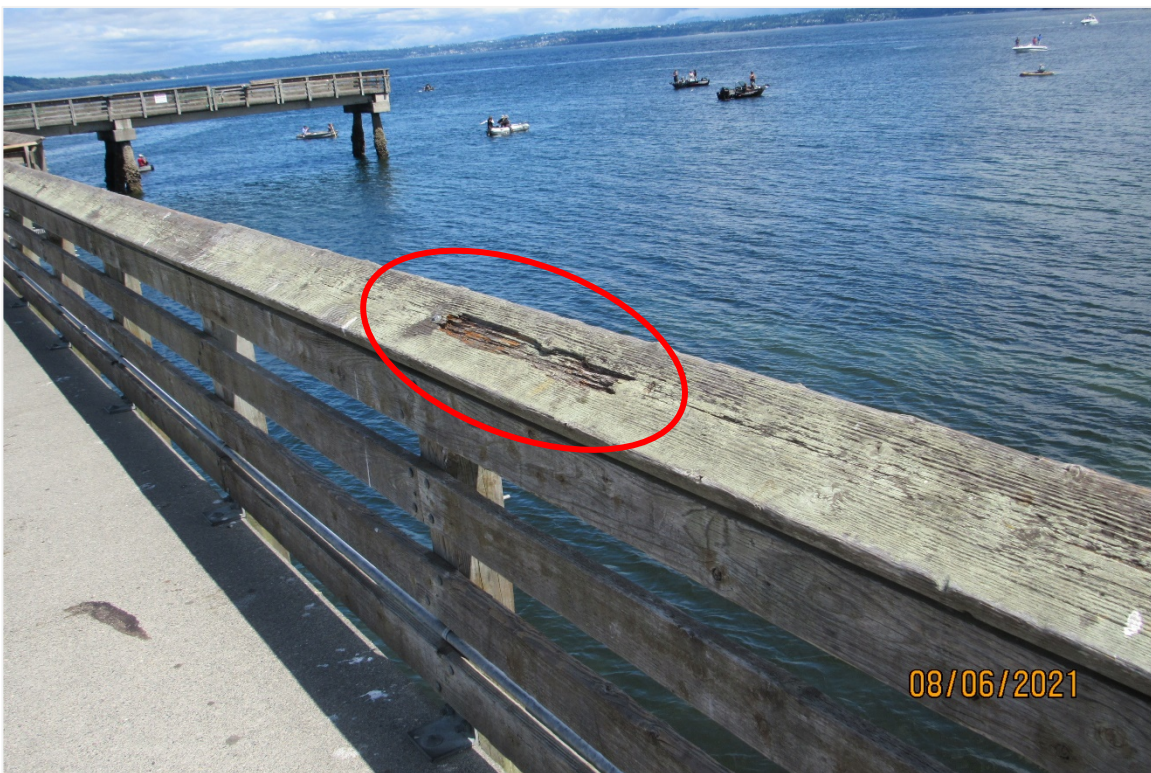
There are 2 areas of decay in the east top railing boards, located at Bent 3.4 and 6.8. Both areas of decay measured up to 2 feet long by full width and up to 1 inch deep. There are 3 missing/broken top railing boards, 1 at the northwest corner of Bent 8, and 2 on the east and west railings at Bent 4, where the aluminum grating starts.

Photograph 22 – View of decay in the east top railing board, near Bent 3.4 shown, looking northeast

Repair Recommendations: It is recommended that the defects in the guardrails be corrected and that the top rail and any damaged or broken timbers be replaced with new timbers.

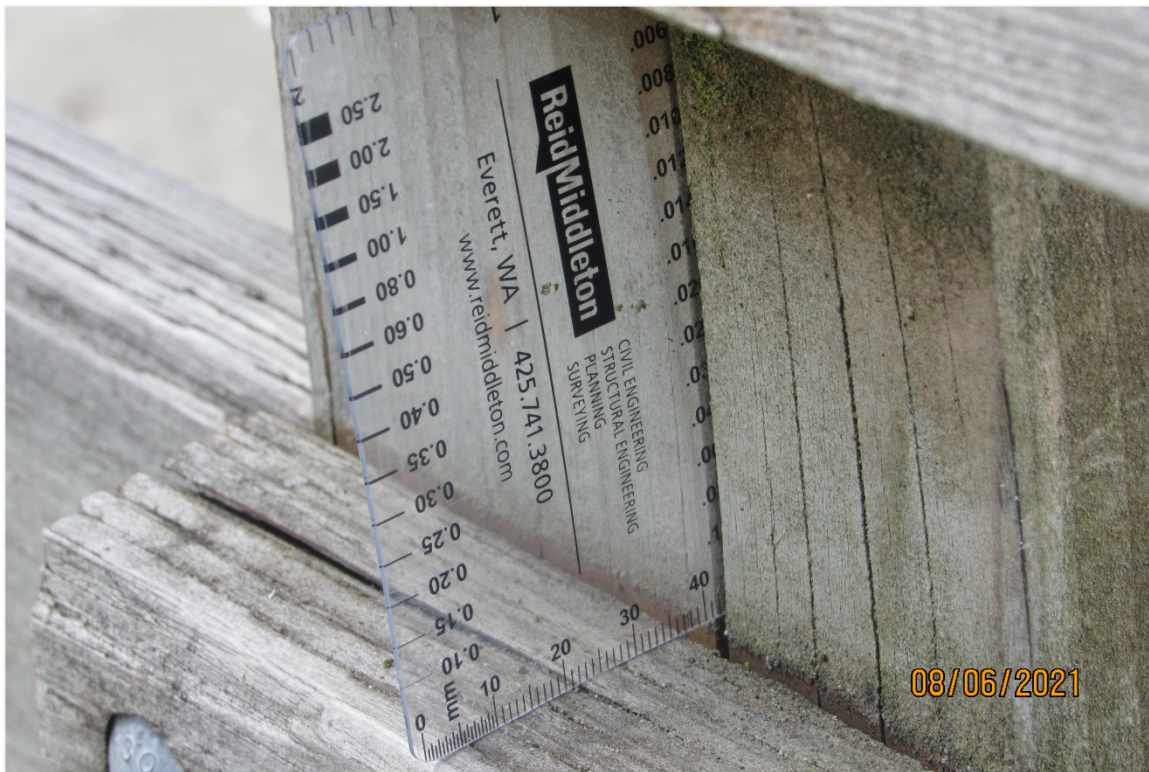
Photograph 23 – View of typical checking in the timber rail posts, looking southwest

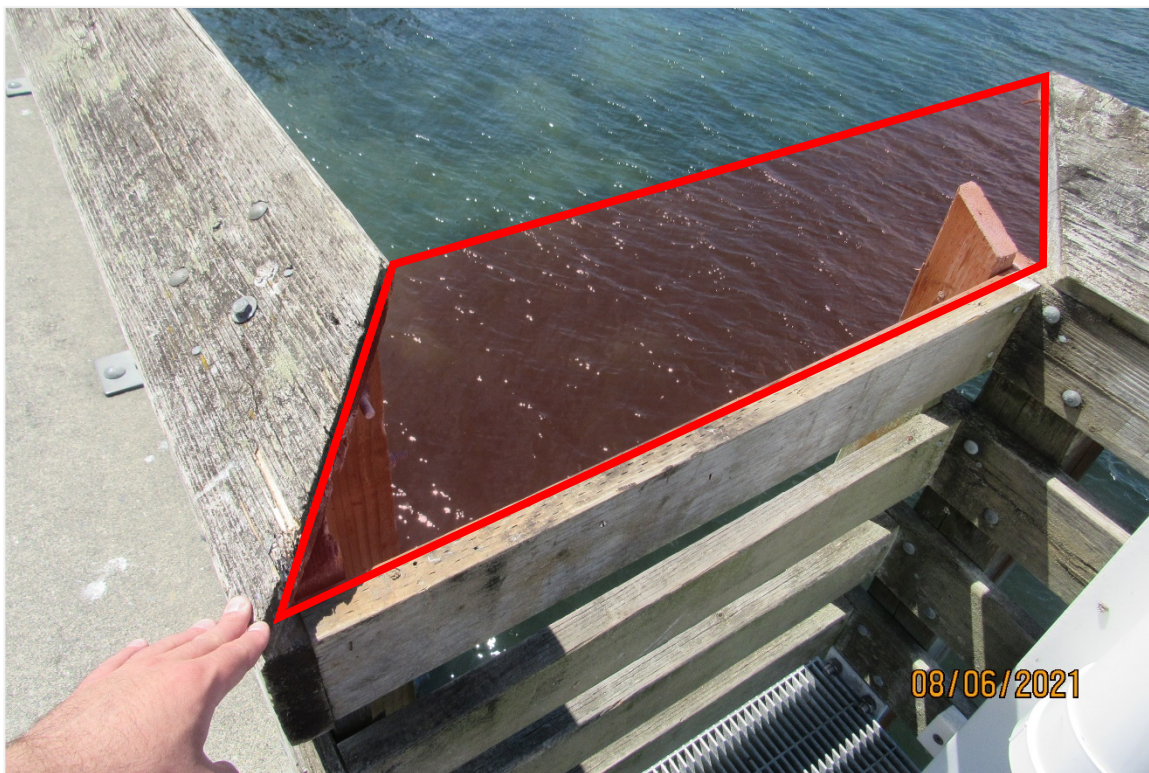
Photograph 24 – View of the west missing top railing at Bent 4, looking southwest

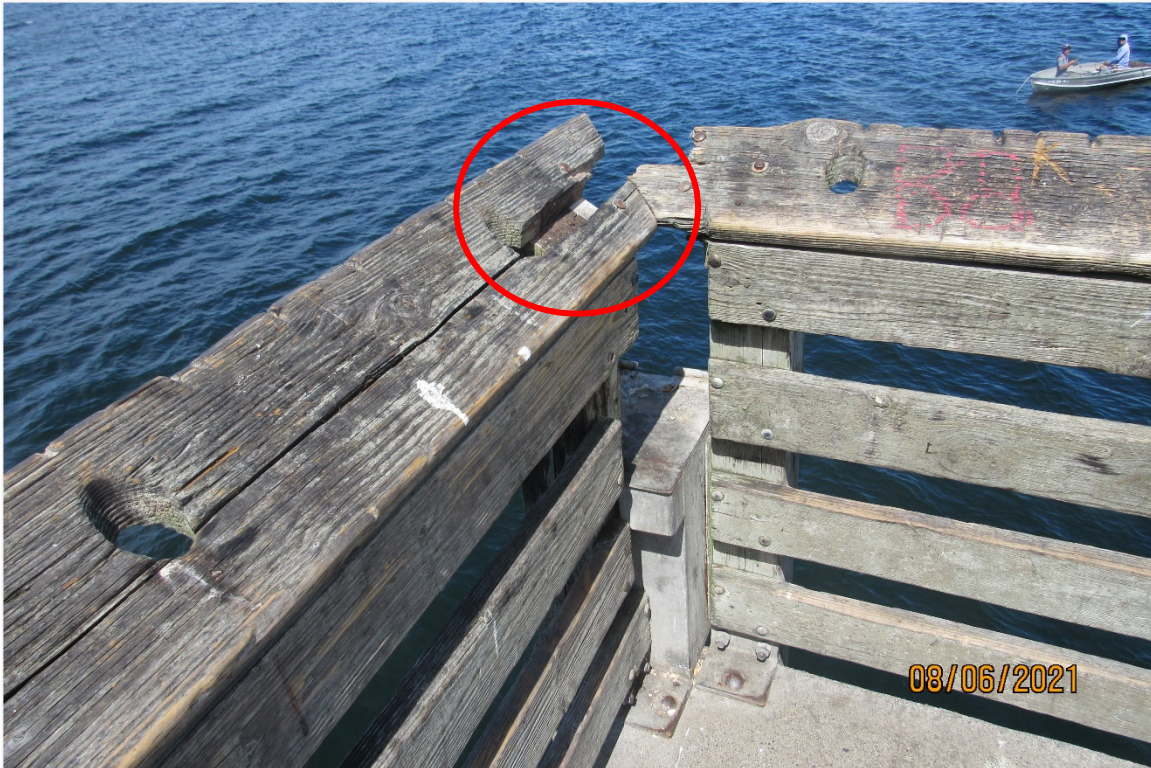
Photograph 25 – View of the broken top rail at the northwest corner of Bent 8, looking north

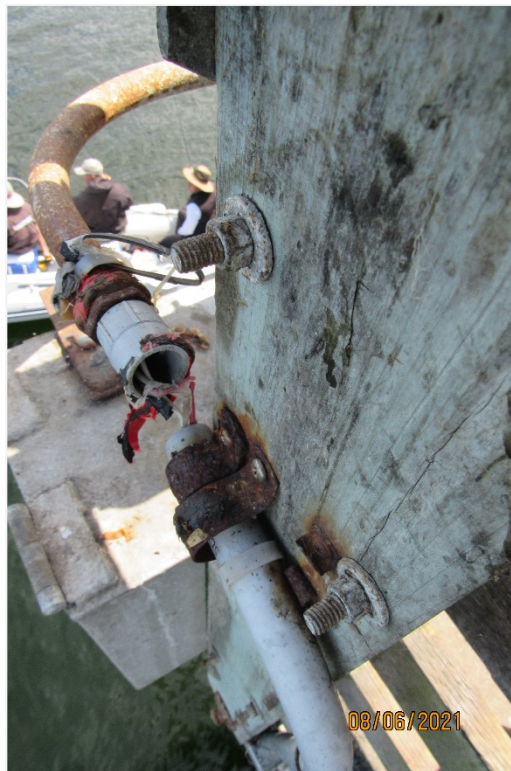
Photograph 26 – View of the disconnected navigational utility line at Bent 10, looking east

Repair Recommendations: It is recommended that the navigation light systems be high priority. Replacing the current pvc conduit system with a new solar powered lights at the corners of the pier is recommended at this time.

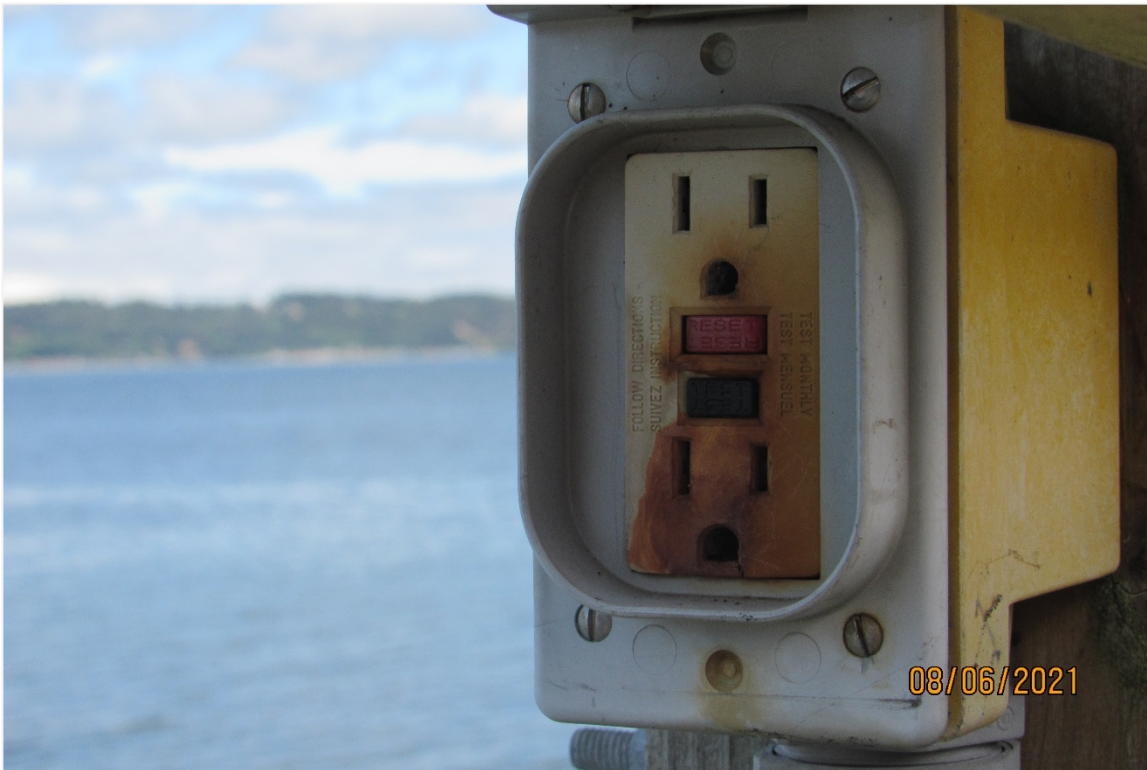
Photograph 27 – View of the typical heavy staining and discoloration on the electrical outlet, looking northwest

Also, prior to the pier reopening to the public, it is recommended that the electrical and potable water lines be considered a less of a priority while the pier is closed to the public. The electrical system should be inspected for code compliance and tested by an electrical engineering firm and replaced if necessary. The potable water line be pressure tested and any leakage locations be repaired. The PVC line from shore should be replaced with galvanized or high-density polyethylene (HDPE) piping and the broken hose bib handle replaced.

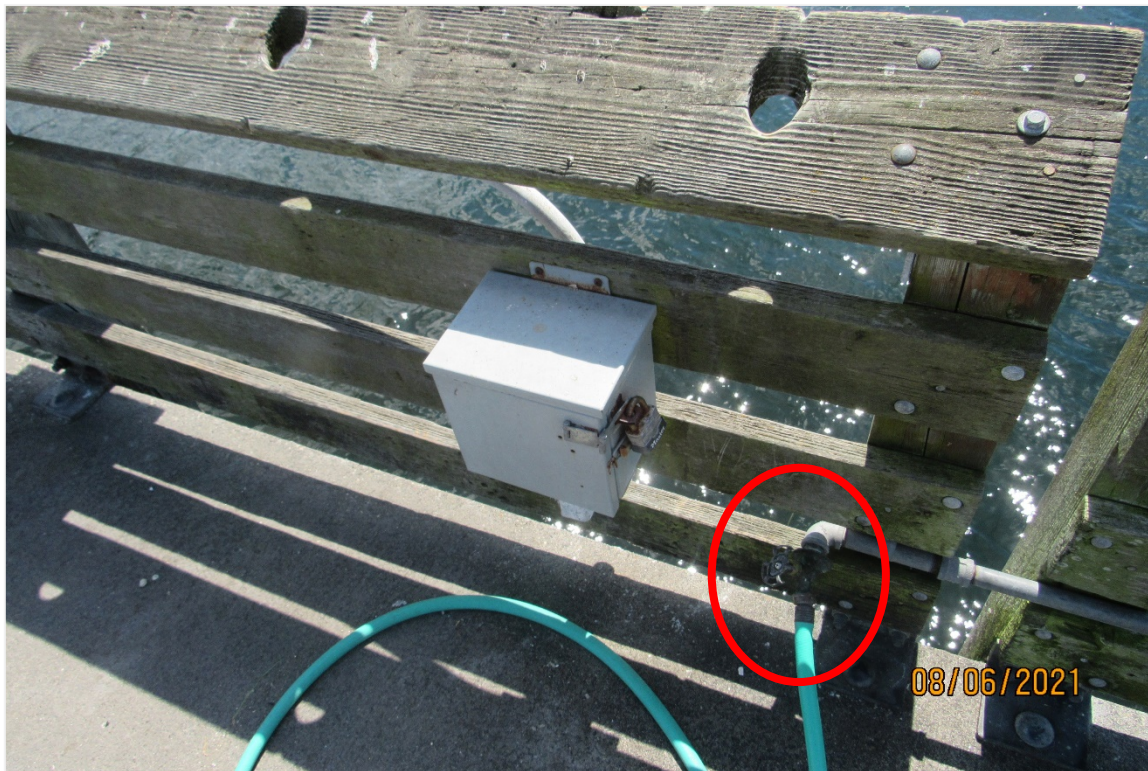
Photograph 28 – View of the potable water receptacle bib at Bent 8.5, looking south
